Kenneth C. Russell, Ph.D, PE
Metallurgical Consultant
Massachusetts Institute of Technology
77 Massachusetts Ave.
Cambridge MA

January 6, 1986

Following is a summary of my findings in the above matter.

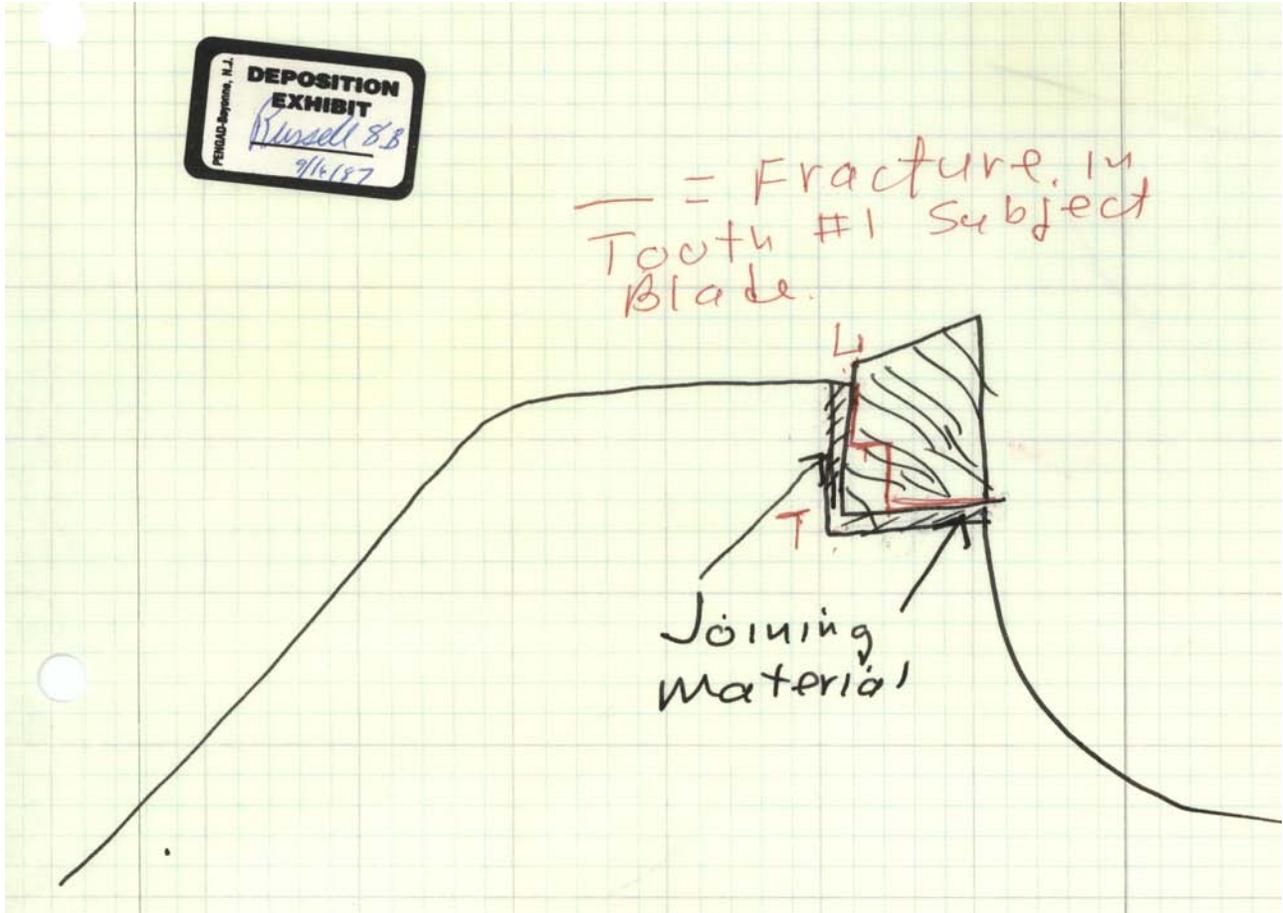
The chip was coated with foreign matter which even repeated cleaning would not remove. SEM study of the chip was therefore not very successful. SEM study of subject tooth 14 (which had chipped due to a fall in the parking lot) showed that the tip had broken through the carbide. Study of subject tooth No. 1 (which had caused the injury) showed that the fracture had occurred about equally through the carbide and along the carbide:solder interface. Fracture was along the carbide:solder interface from the tip of the tooth to about halfway to the base of the carbide, and through the carbide the rest of the way. I enclose SEM print GC-20 which shows subject tooth No. 1 and on which I have written some notations. The tip of the tooth is at the bottom of the print. The threaded objects are set screws which hold the tooth in place in the microscope. The “pock marks” in the joining material are crater-like pores, left during the joining process. The pores would diminish the strength of the joint somewhat.

Higher magnification SEM study of the joining material near the tip of subject tooth No. 1 revealed that whereas in the half of the joint nearest the tip, the joining material had peeled away from the carbide tip in a proper, ductile manner, the half nearest the remaining carbide showed no deformation. The lack of deformation shows that the carbide tip had never been bonded to the joining material. Print GC-20 shows a clear line of demarcation between the two regions.

Figure 1: Schematic of saw blade, showing how the carbide tooth fractured both along the joint and through the carbide.

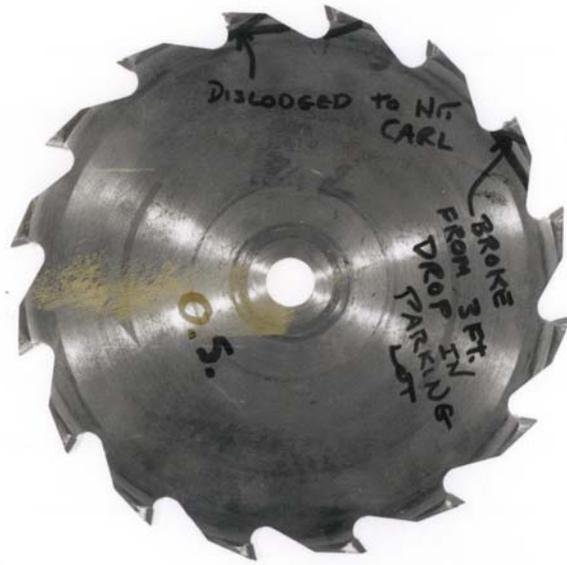
Figure 2: Subject blade, showing multiple broken teeth.

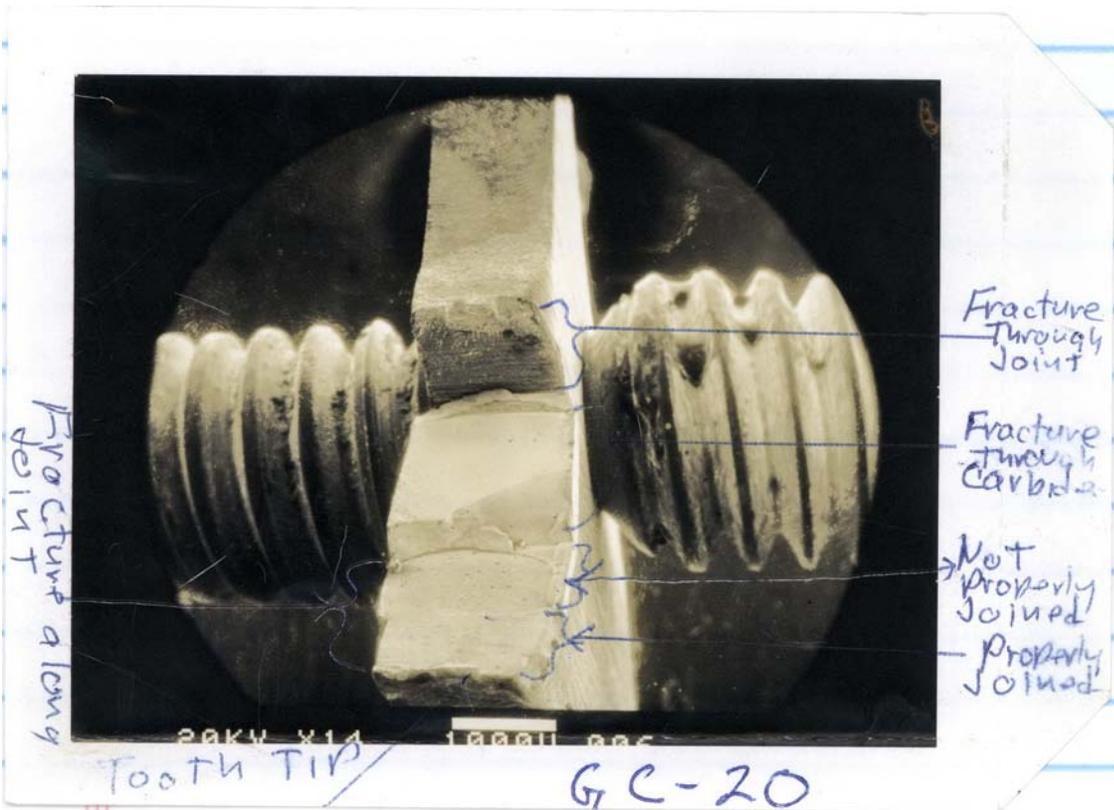
The forces on the tooth tip during operation are such as to cause the carbide tip to tend to “pull away” from the joining material in the nonbonded region. Therefore, the absence of a proper bond on the region observed is especially deleterious and would lead to a significant decrease in the force needed to remove the tip from the tooth.

There are various possible causes of an improper joint of the type found on subject tooth No. 1; improper cleaning or fluxing, or improper control of temperature or atmosphere are common causes of such poor joints.

Figure 3: Detached tooth No. 1 in SEM mount, edge-on, showing fracture through the joint and the carbide.
