Kenneth C. Russell, Ph.D, PE
Metallurgical Consultant
Massachusetts Institute of Technology
77 Massachusetts Ave.
Cambridge MA 02139

March 31, 1980

This letter describes my part of the investigation in the above case. This investigation undertaken with Dr. [redacted], who was to consider the structural and design aspects of the ladder, while I was to consider metallurgical factors.

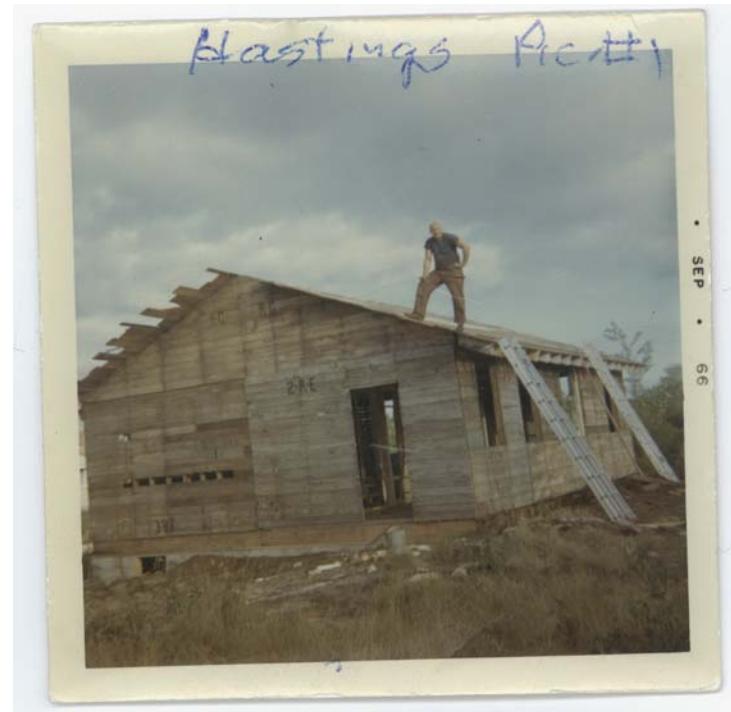
Test	Description
A-1	Ladder A extended to 17', placed at proper 1:4 angle, with base 4.5 feet from house and loads at center of rungs. Ladder shaken by hand while loaded. Result: Modest deflection, ladder seems stable.
A-2	Move base of ladder to 6.5 feet from wall, locate loads at extreme left of rungs to give maximum off center loading, shake ladder. Result: More deflection, less rigid, still no sign of failure.
A-3	As A-2, except ladder base now 8.5 feet back from wall. Result: Big deflection of left rail (recorded photographically) but still no failure. The deflection could have been frightening to a human on the ladder. The ladder resumed its original configuration when overloaded.
A-4	From vertical position, drop ladder on side three times on asphalt driveway. Result: No buckling of flanges, though the top of the down rail bent slightly.

Figure 1: Ladder testing.

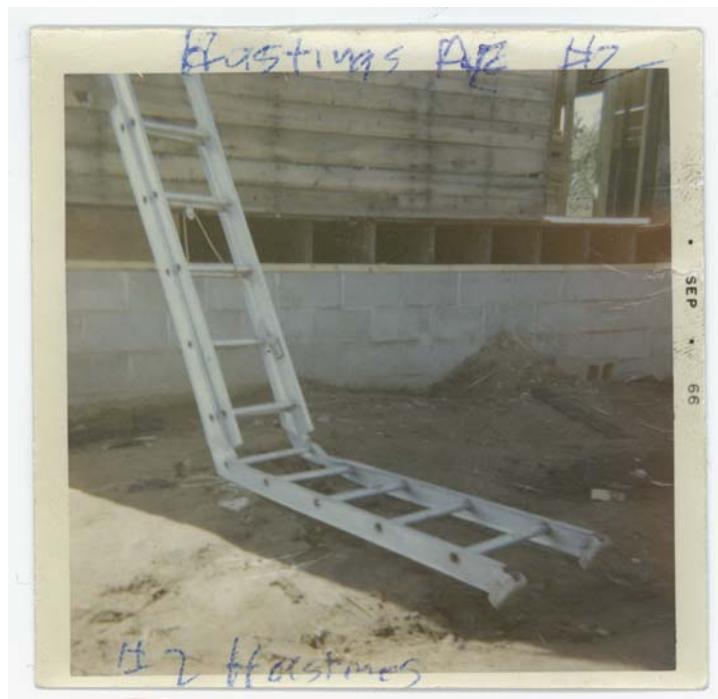
Test	Description
B-1	Ladder B, placed at proper angle, left hook not fastened, loaded at middle only, shaken. Result: Neither failure nor excessive deflection.
B-2	As B-1, but loaded at top and middle. Result: Pronounced bow to right, but no failure.
B-3	As B-2, but base of ladder moved to 6.5 feet from wall. Result: Failure of upper flange of lower right rail near the bottom of the top section (recorded photographically, Fig. 2).

Dr. [Redacted]'s report will go into the design implications of the test results. It is clear, though, that the ladder was designed with a large margin of safety, as it failed only after being simultaneously:

1. Overloaded two-fold;
2. Used at too shallow an angle;
3. Used with only one hook attached.

Figure 2: Failed aluminum ladder.
