# Report on the Greenhouse Collapse

Kenneth C. Russell

Department of Metallurgy

27 March 1969

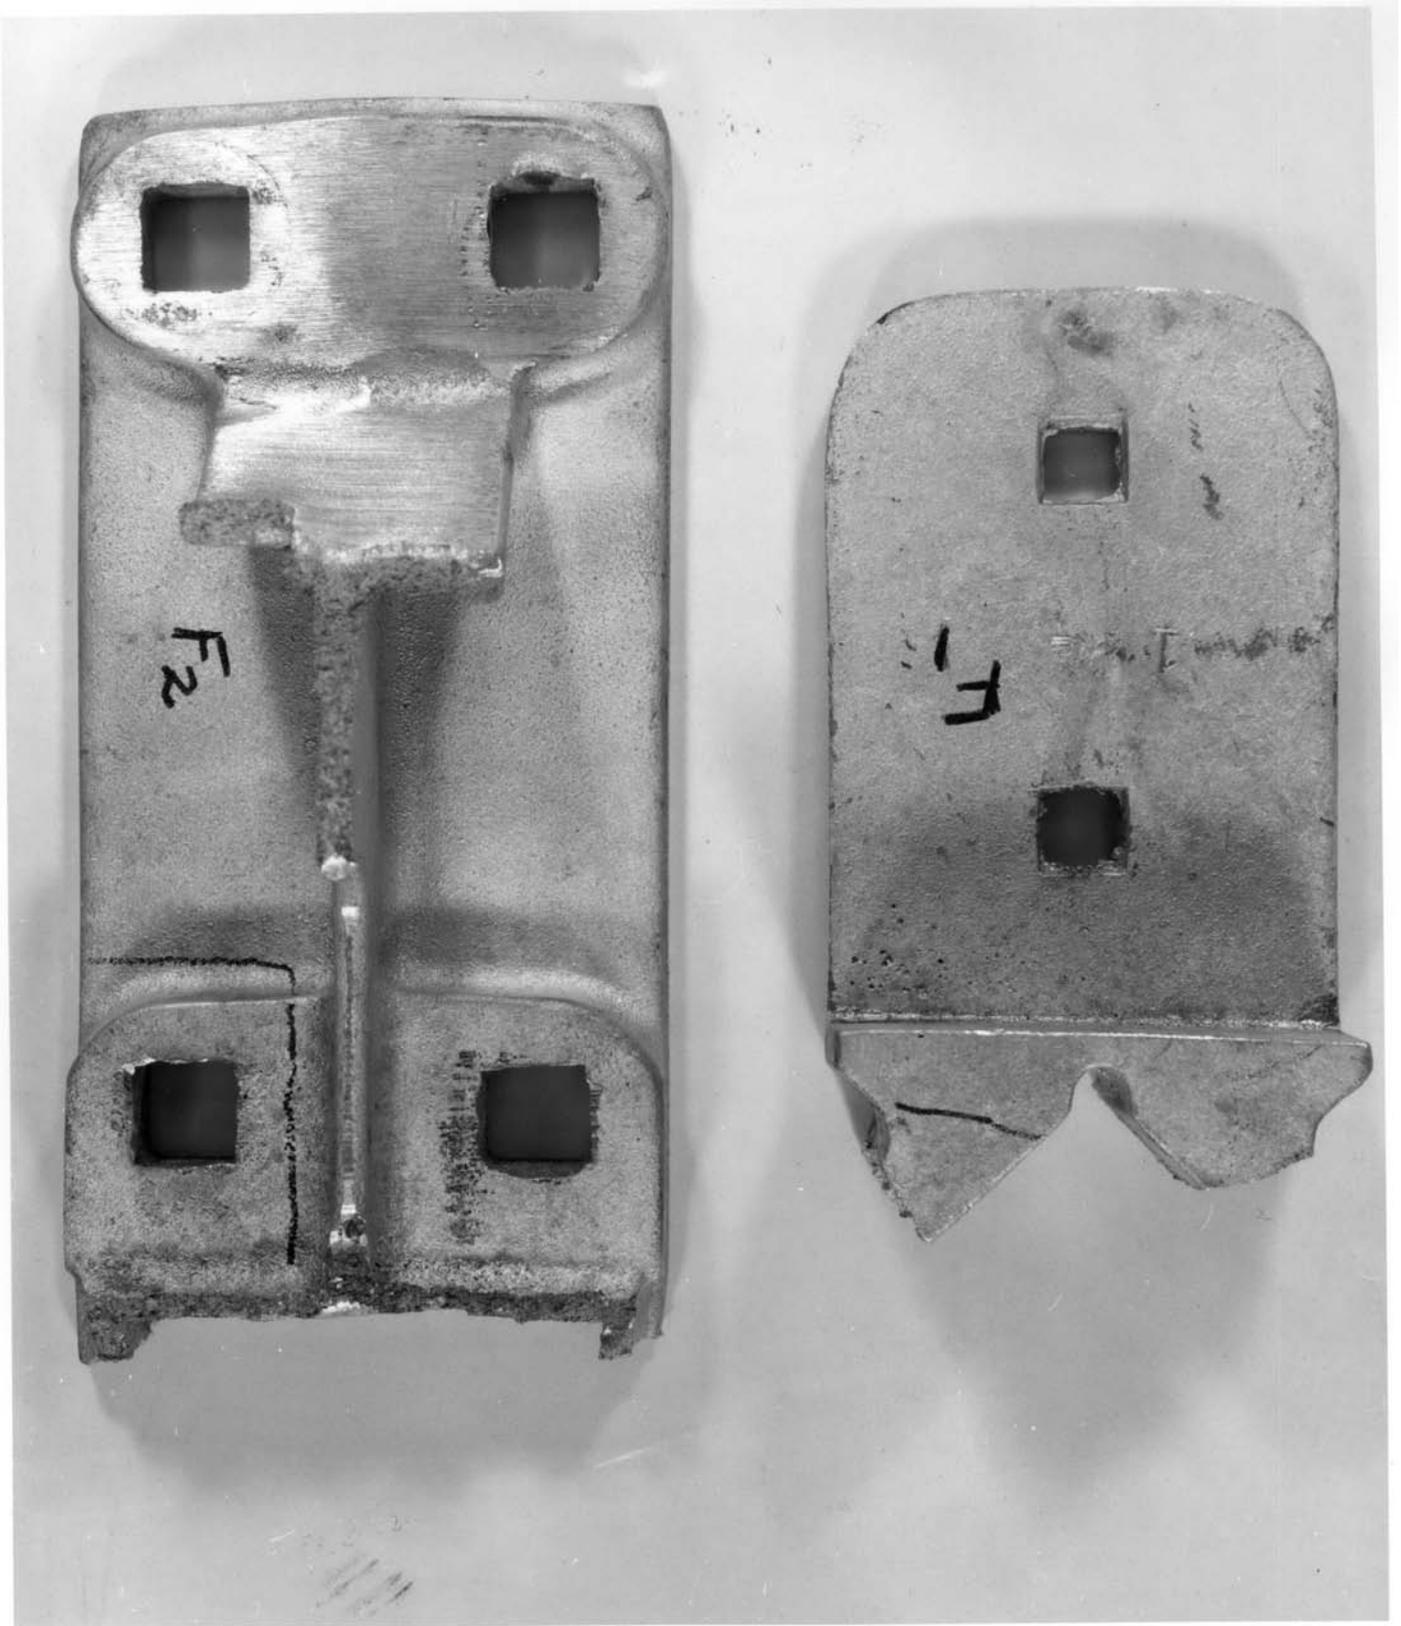
Evaluation of the castings was mainly by means of metallographic examination. Macroscopic examination of the failed castings indicated extensive porosity, and both the gutter support casting (Fig. 1) and two primary castings (Figs. 5, 10) were sectioned near the fracture surfaces for microscopic examination.

The photomicrographs presented are typical, and do not represent the most porous regions. The void distribution is highly irregular, and in some regions a dozen or more voids are clustered together, giving a very weak region. The gutter support appears to have fractured in part through such a cluster of voids.

Figure 1: Fractured gutter support casting (right).

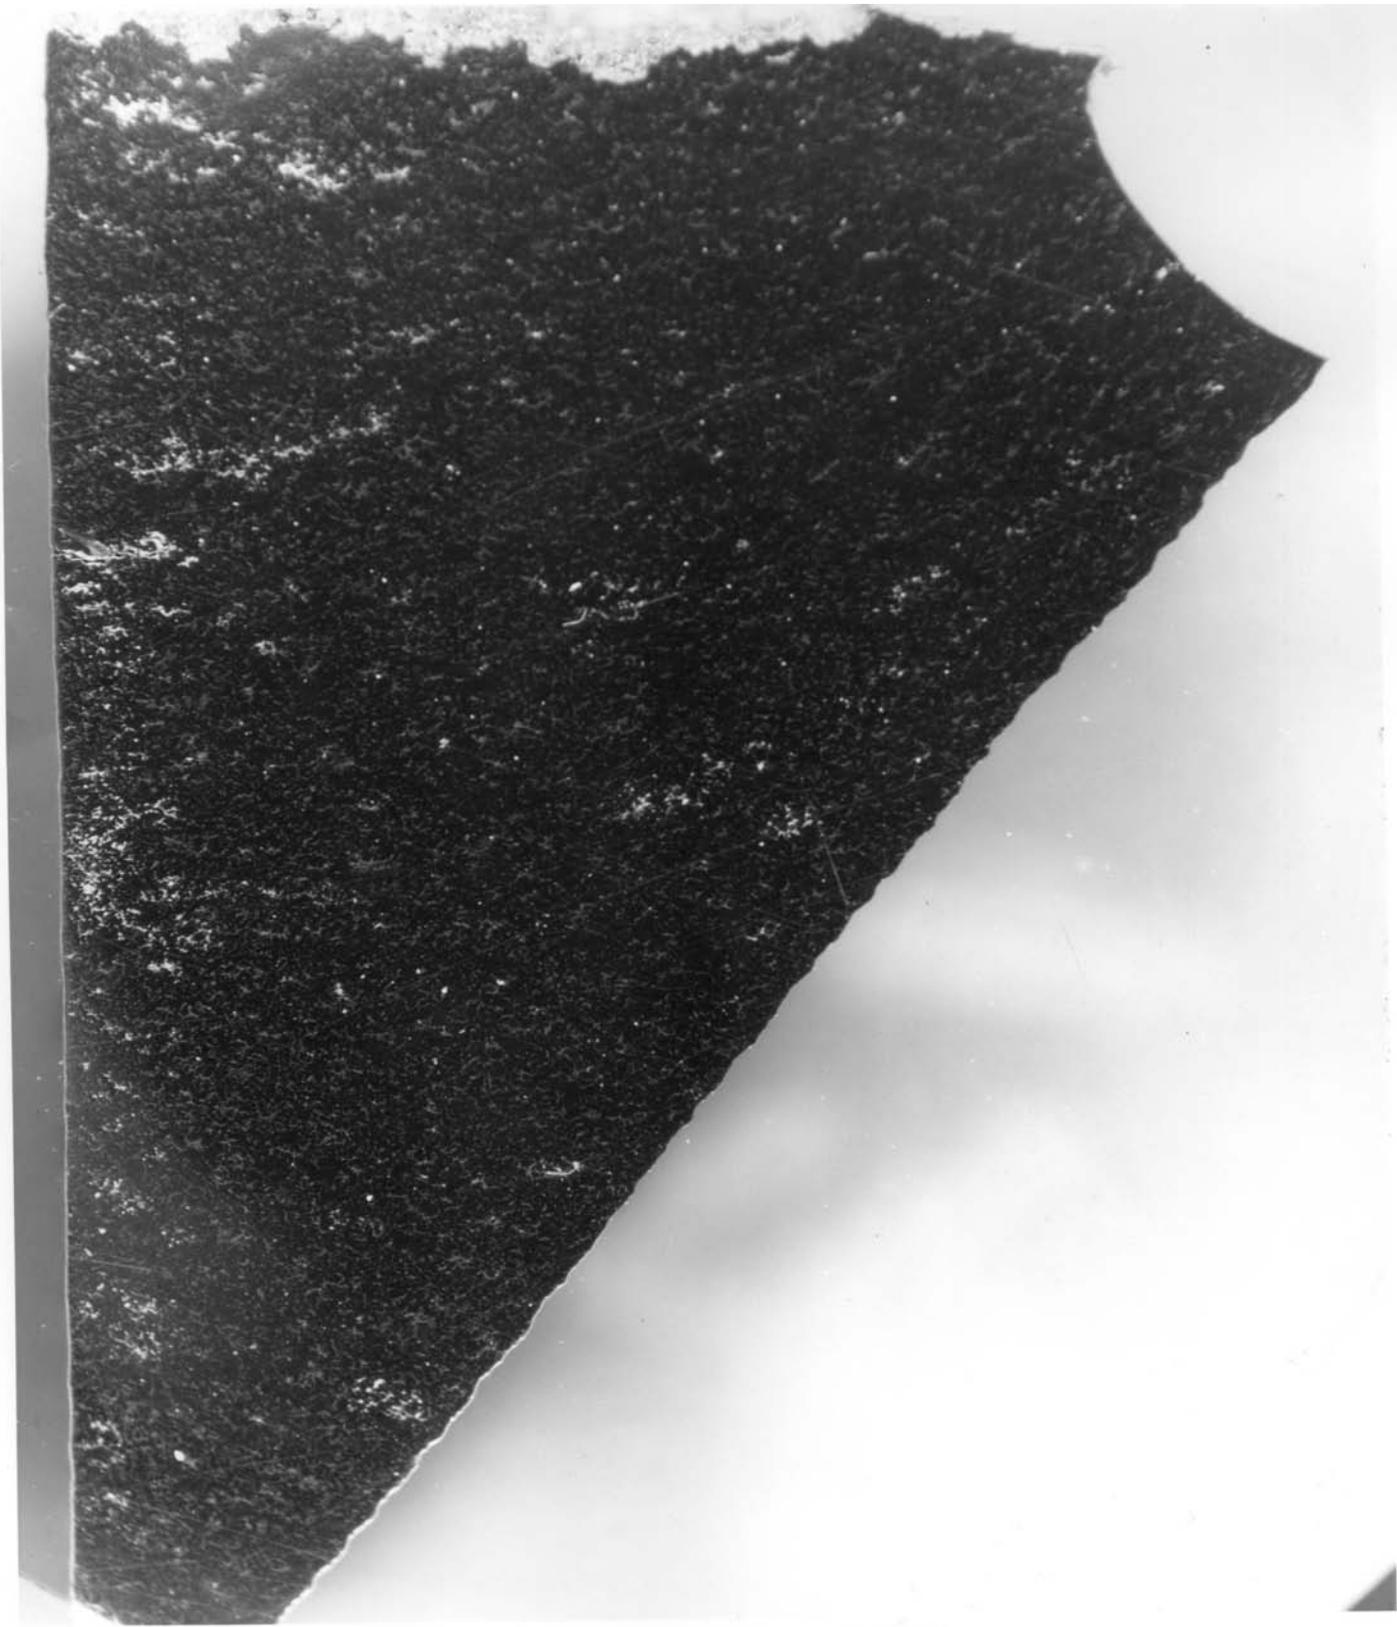
Fig. 2 is a photo macrograph of a section of the gutter support, wherein the white regions are voids. Porosity is extensive, and many of the finer pores are not visible. Figs. 3 and 4 show the porosity at the edge of the casting in the as-polished and the etched conditions. The pores are partly angular and partly rounded.

Figure 2: Photomicrograph of fractured gutter support.

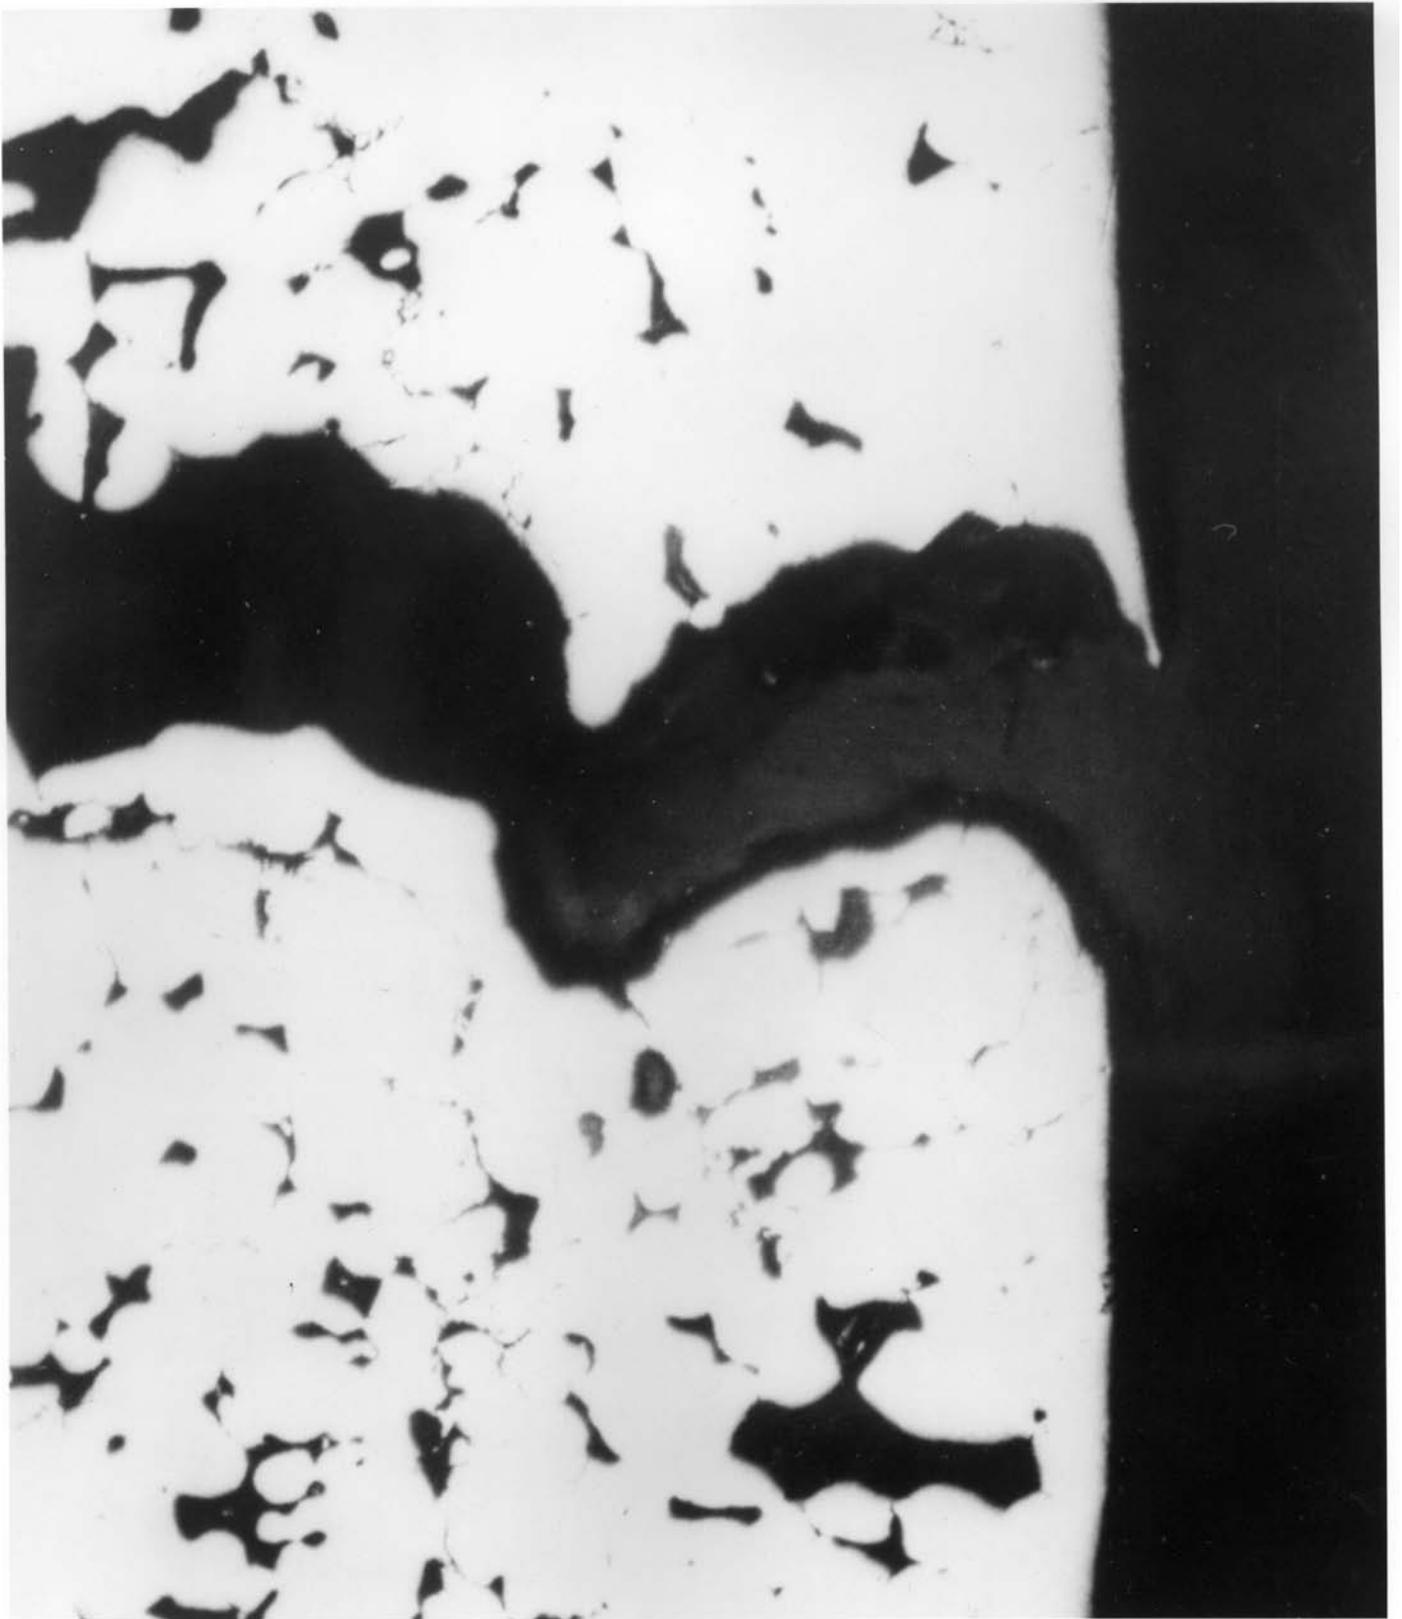
Figure 3: As-polished fractured gutter support casting. (200X)

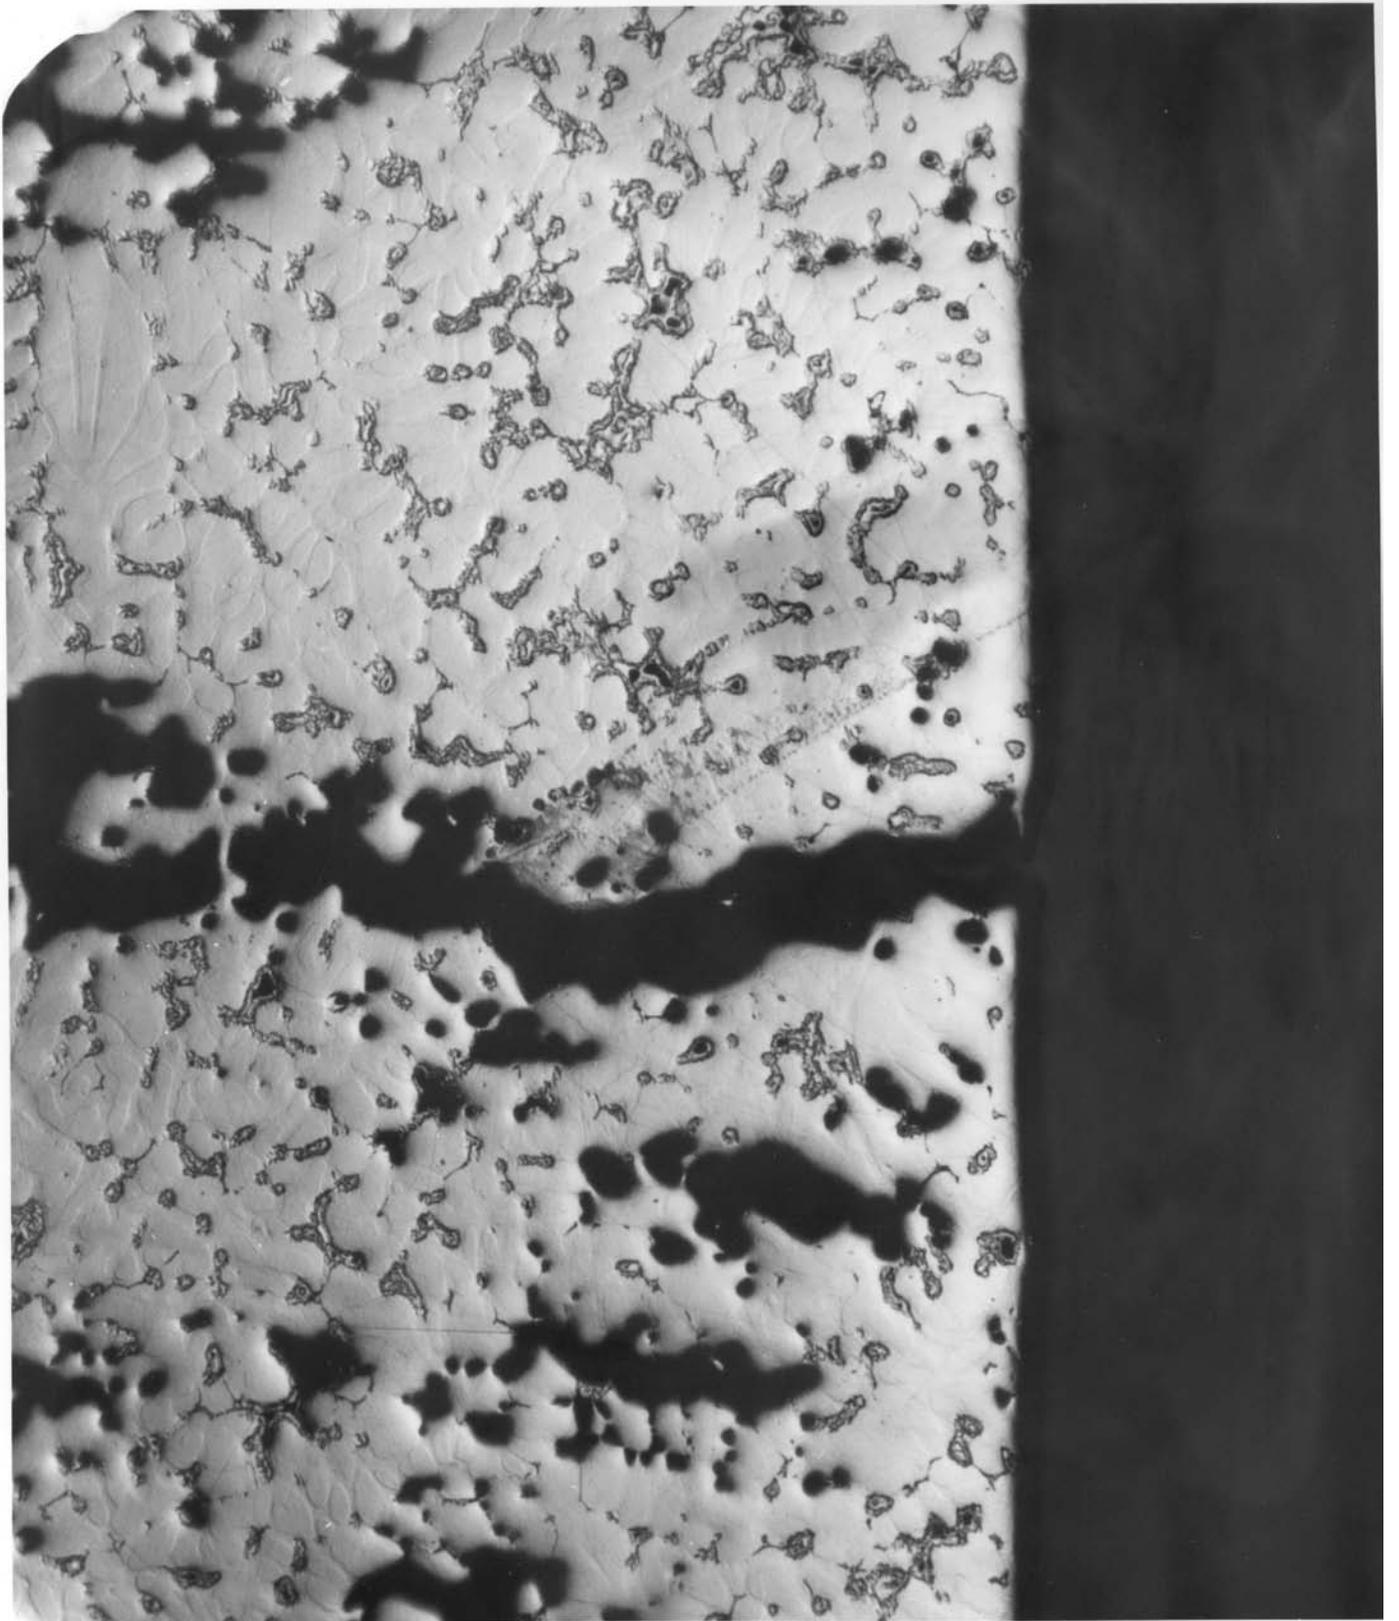
Figure 4: Etched fractured gutter support casting. (100X)

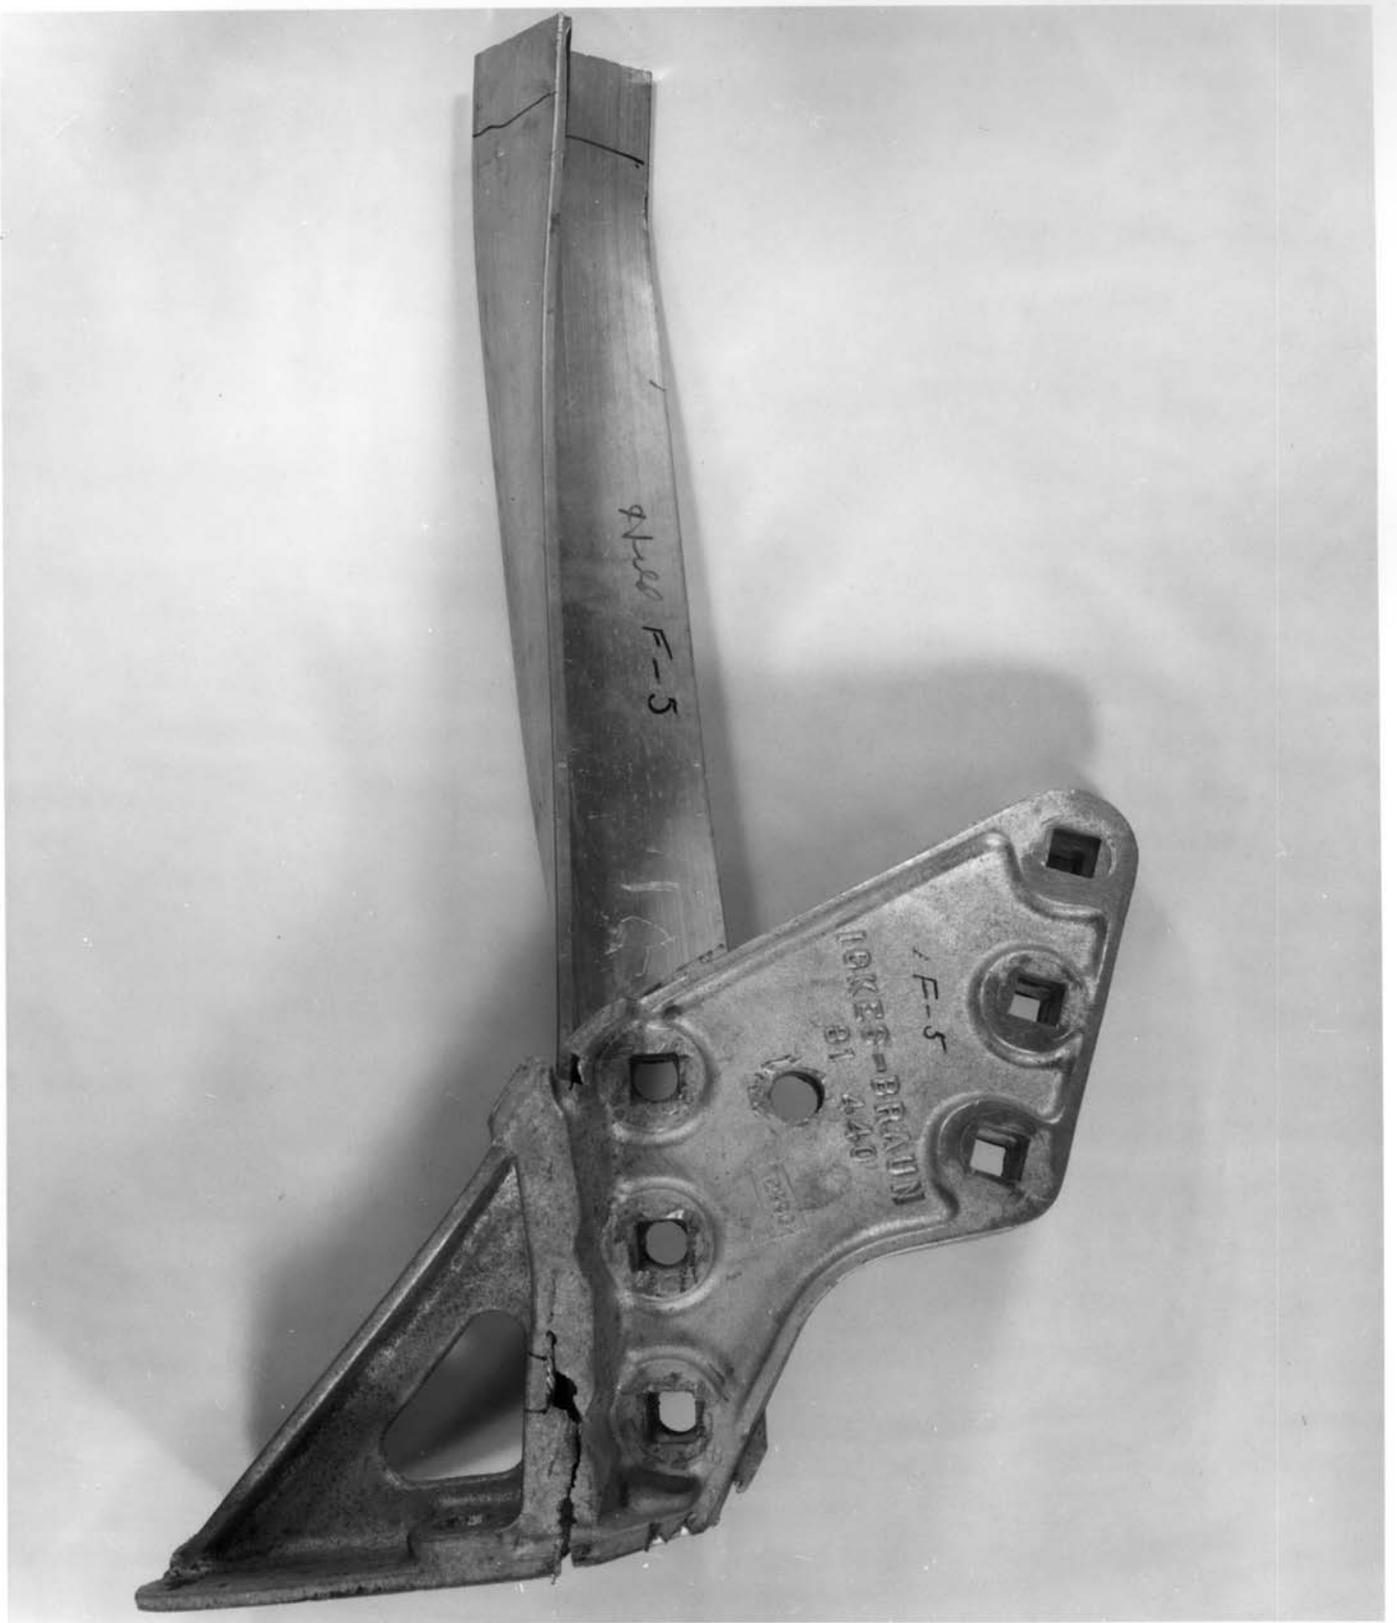
Figure 5: Fractured primary casting with roof chord.

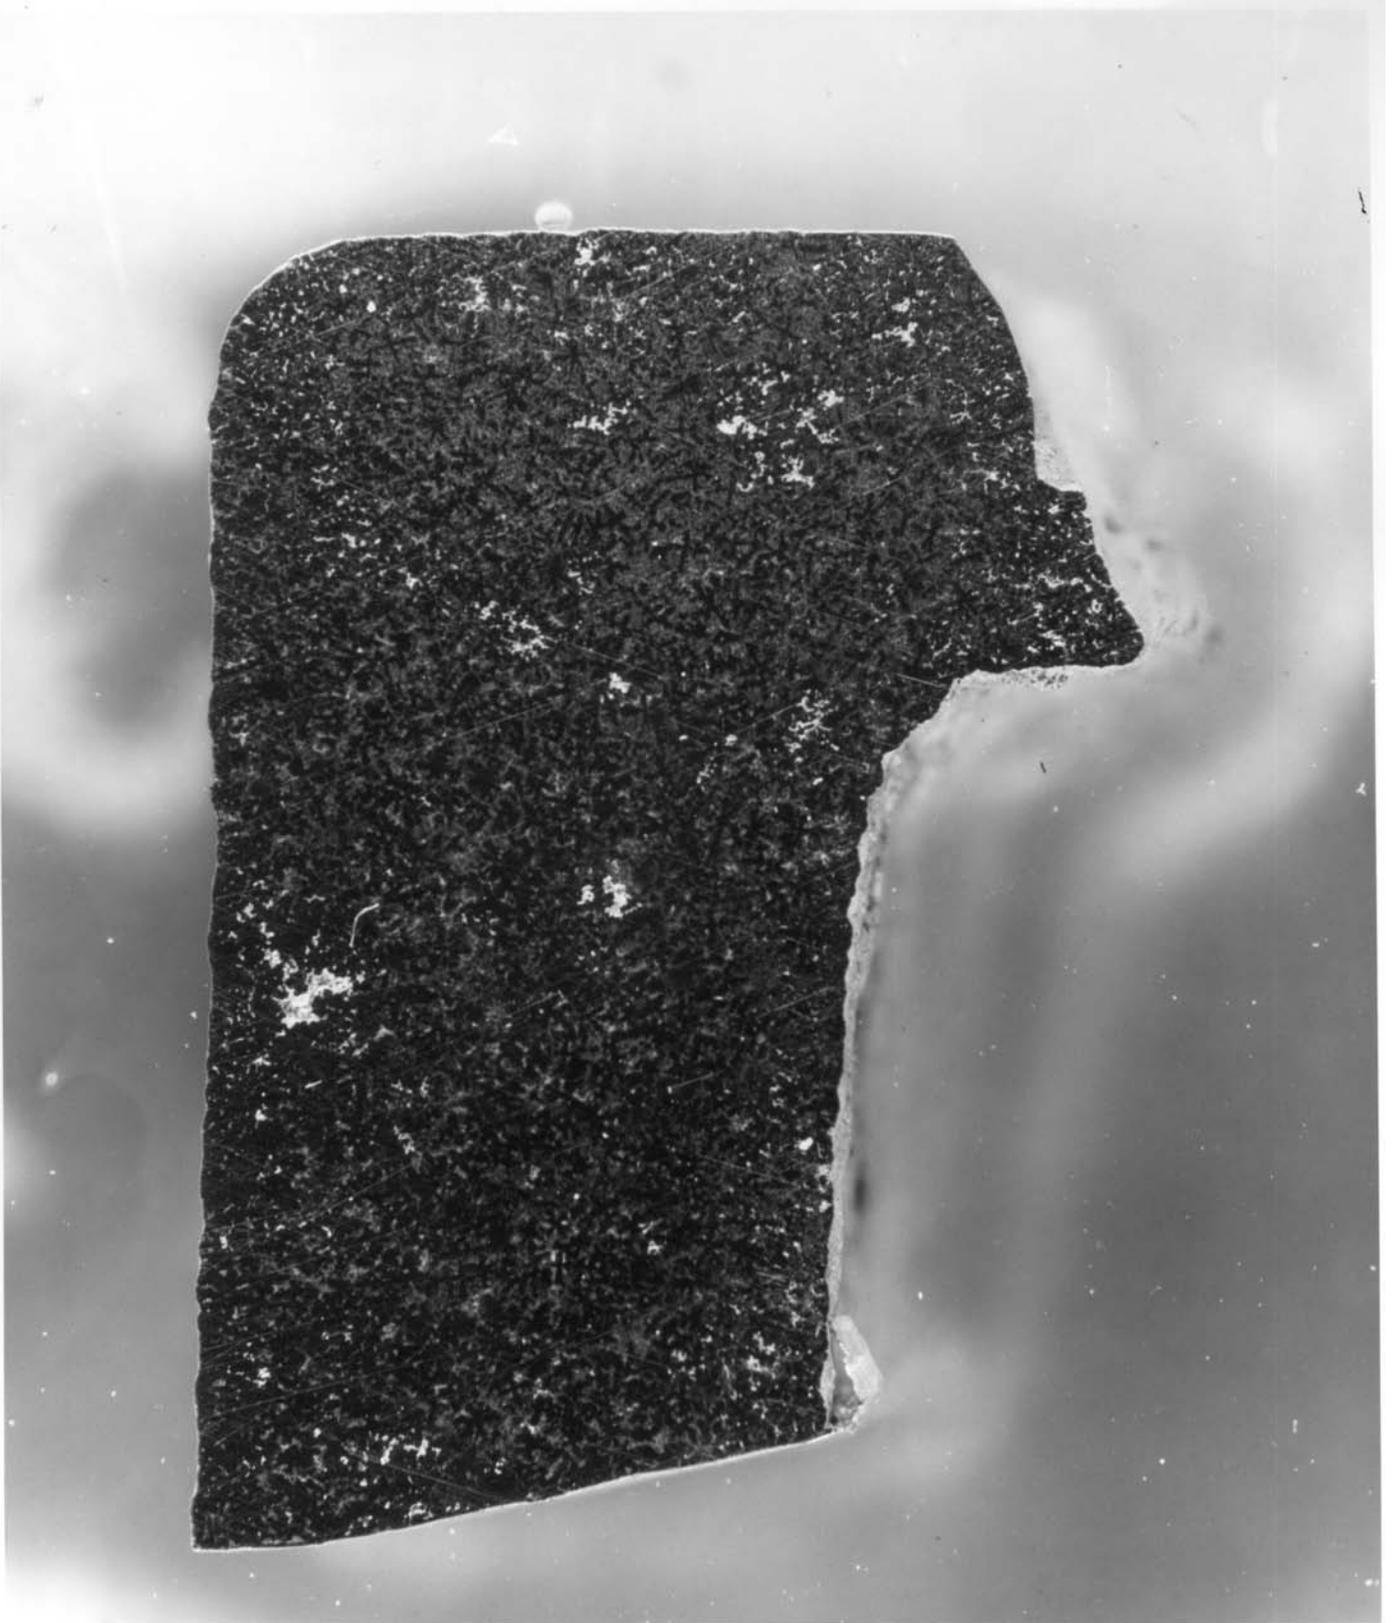
Figs. 6 and 7 are two sections of the same primary casting (Fig. 5) and Fig. 11 is a section of another primary casting (Fig. 10). Extensive white regions, denoting porosity are visible in all three sections. Figs. 8 and 9 show the interior of the primary casting in Fig. 5. Extensive porosity is again seen, of the partly angular, partly rounded, geometry.

Figure 6: Transverse photomicrograph of primary casting.

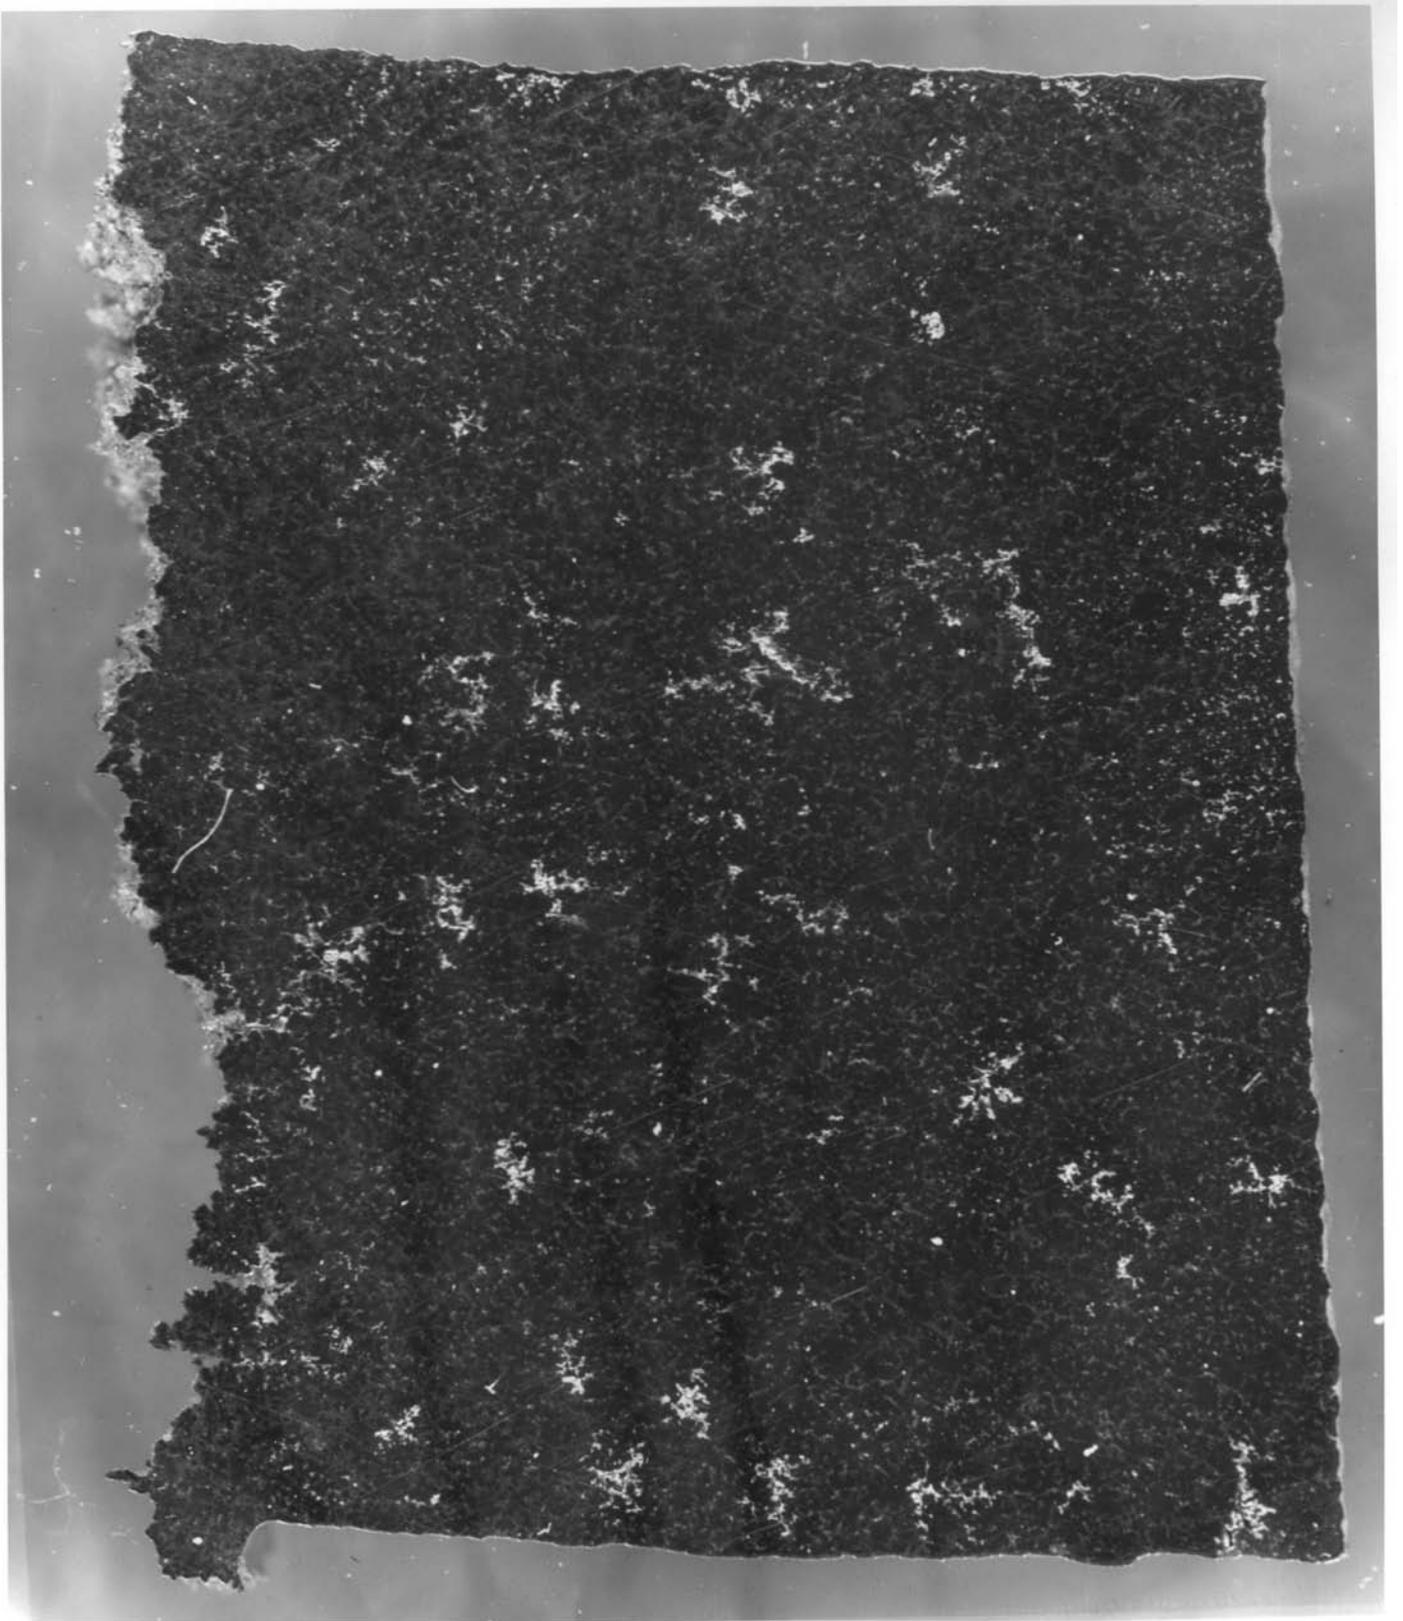
Figure 7: Longitudinal photomicrograph of primary casting.

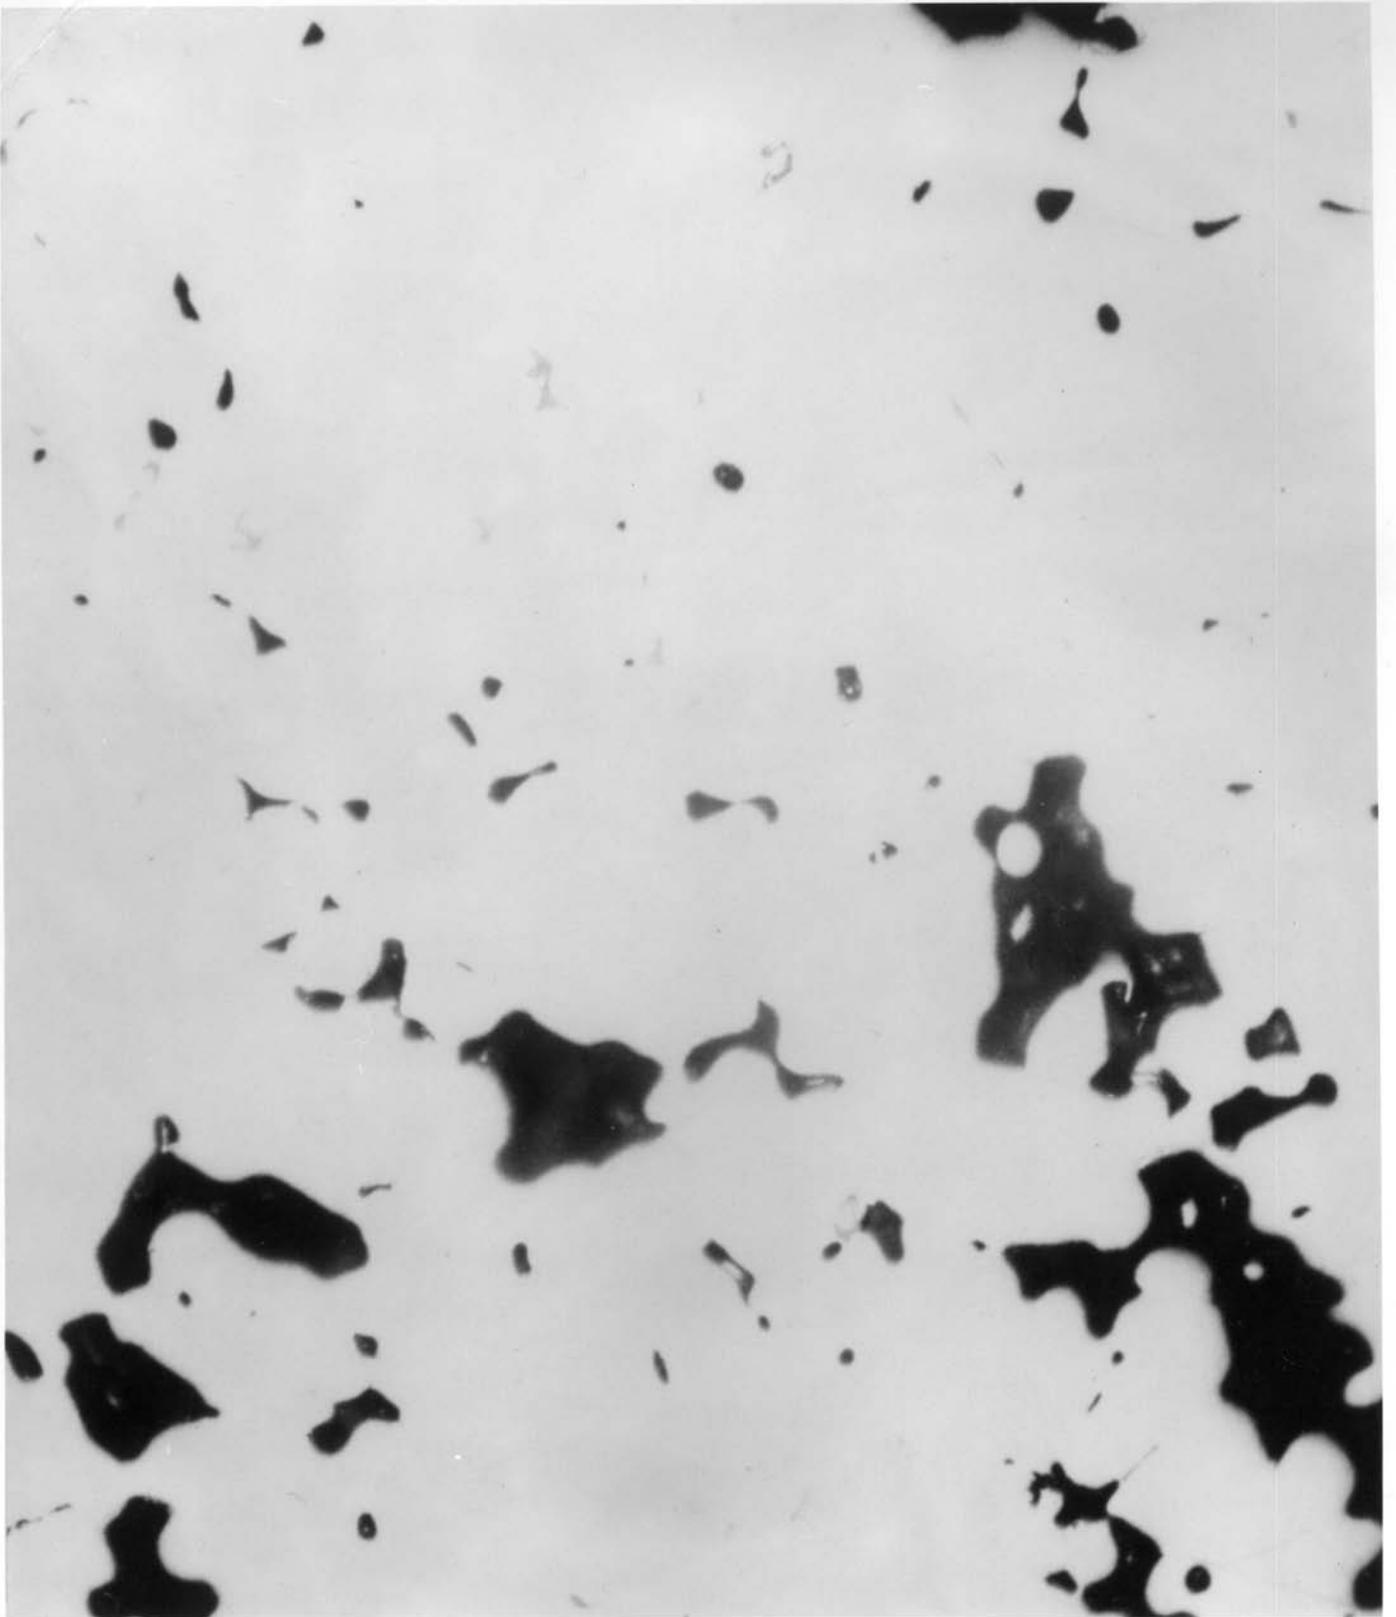
Figure 8: As-polished interior of fractured primary casting. (200X)

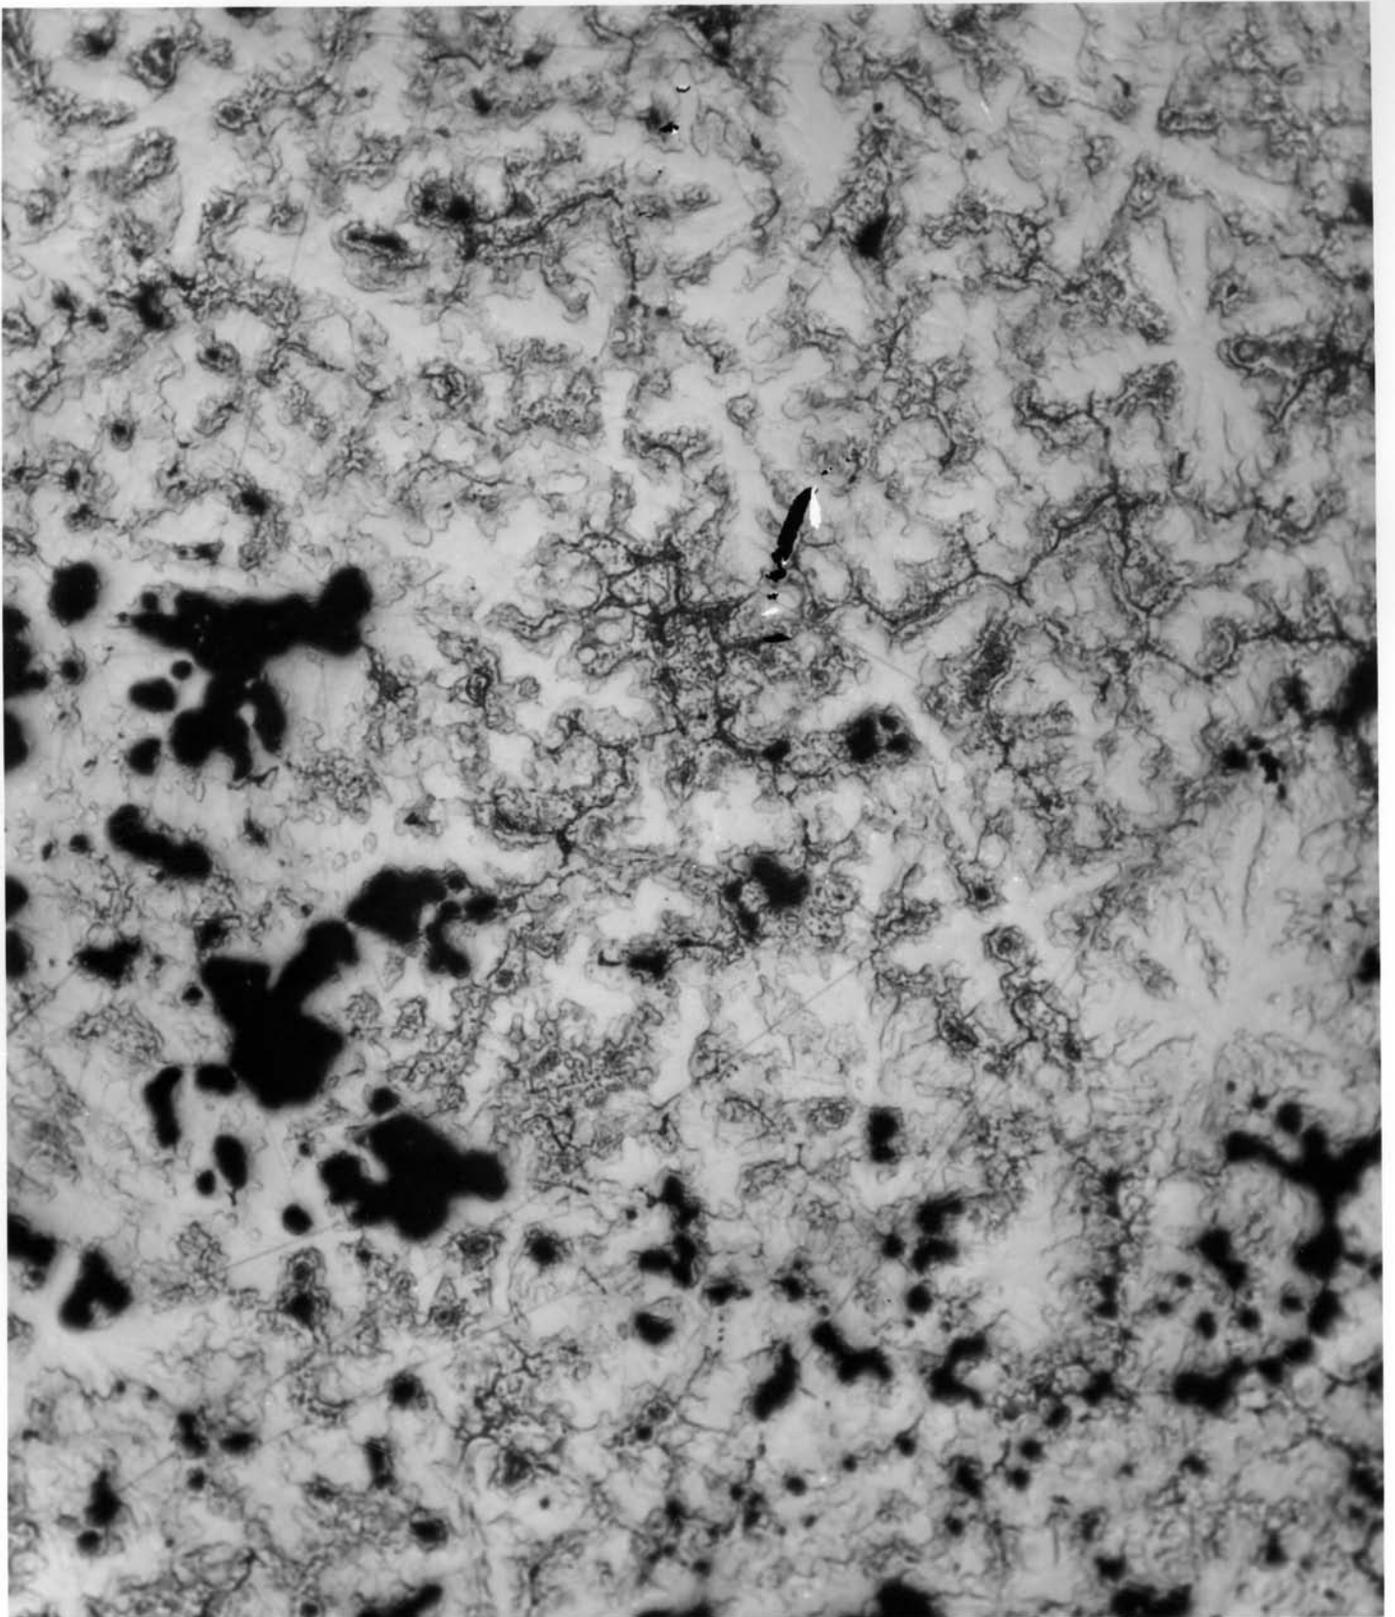
Figure 9: Etched interior of fractured primary casting. (100X)

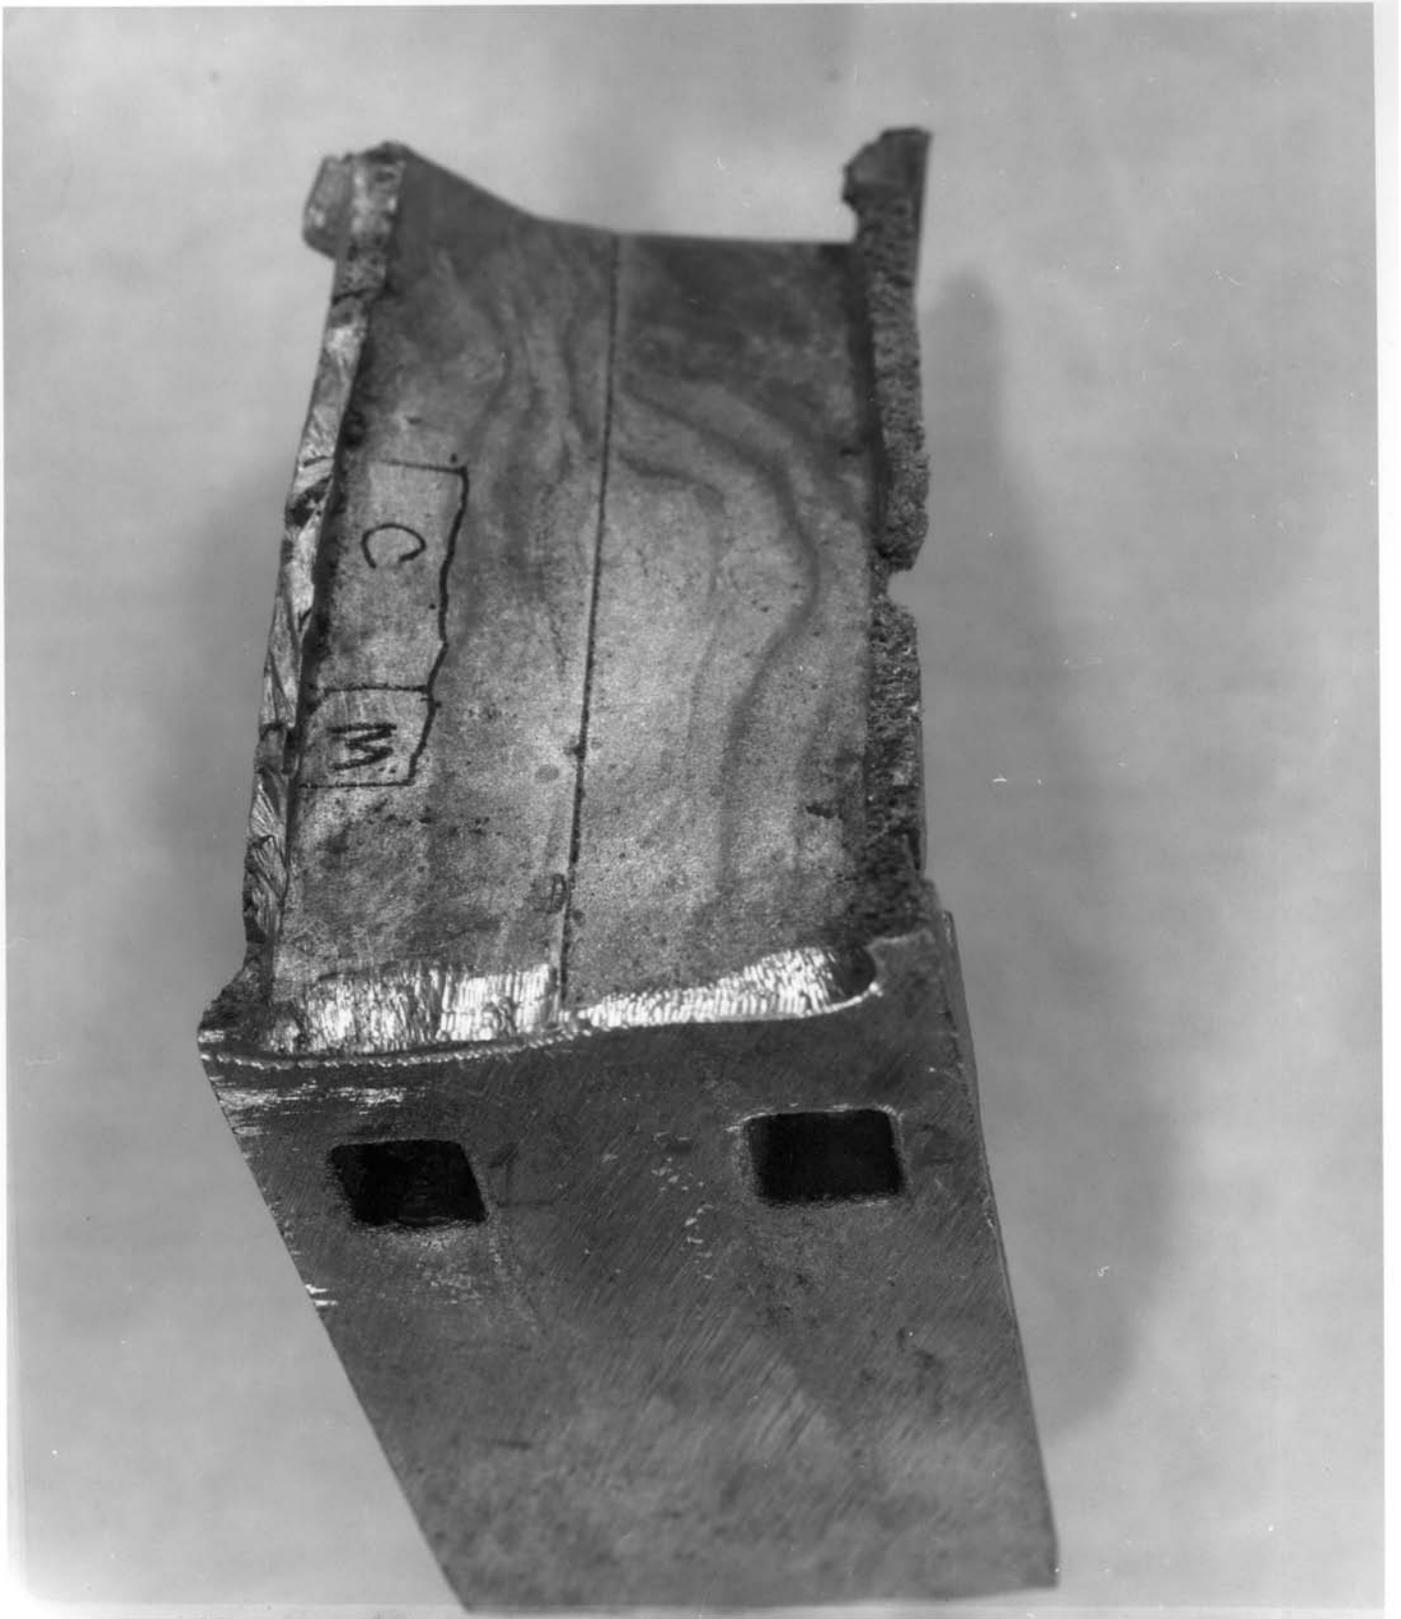
Figure 10: Another fractured primary casting.
