# Report on the Greenhouse Collapse

Kenneth C. Russell

Department of Metallurgy

27 March 1969

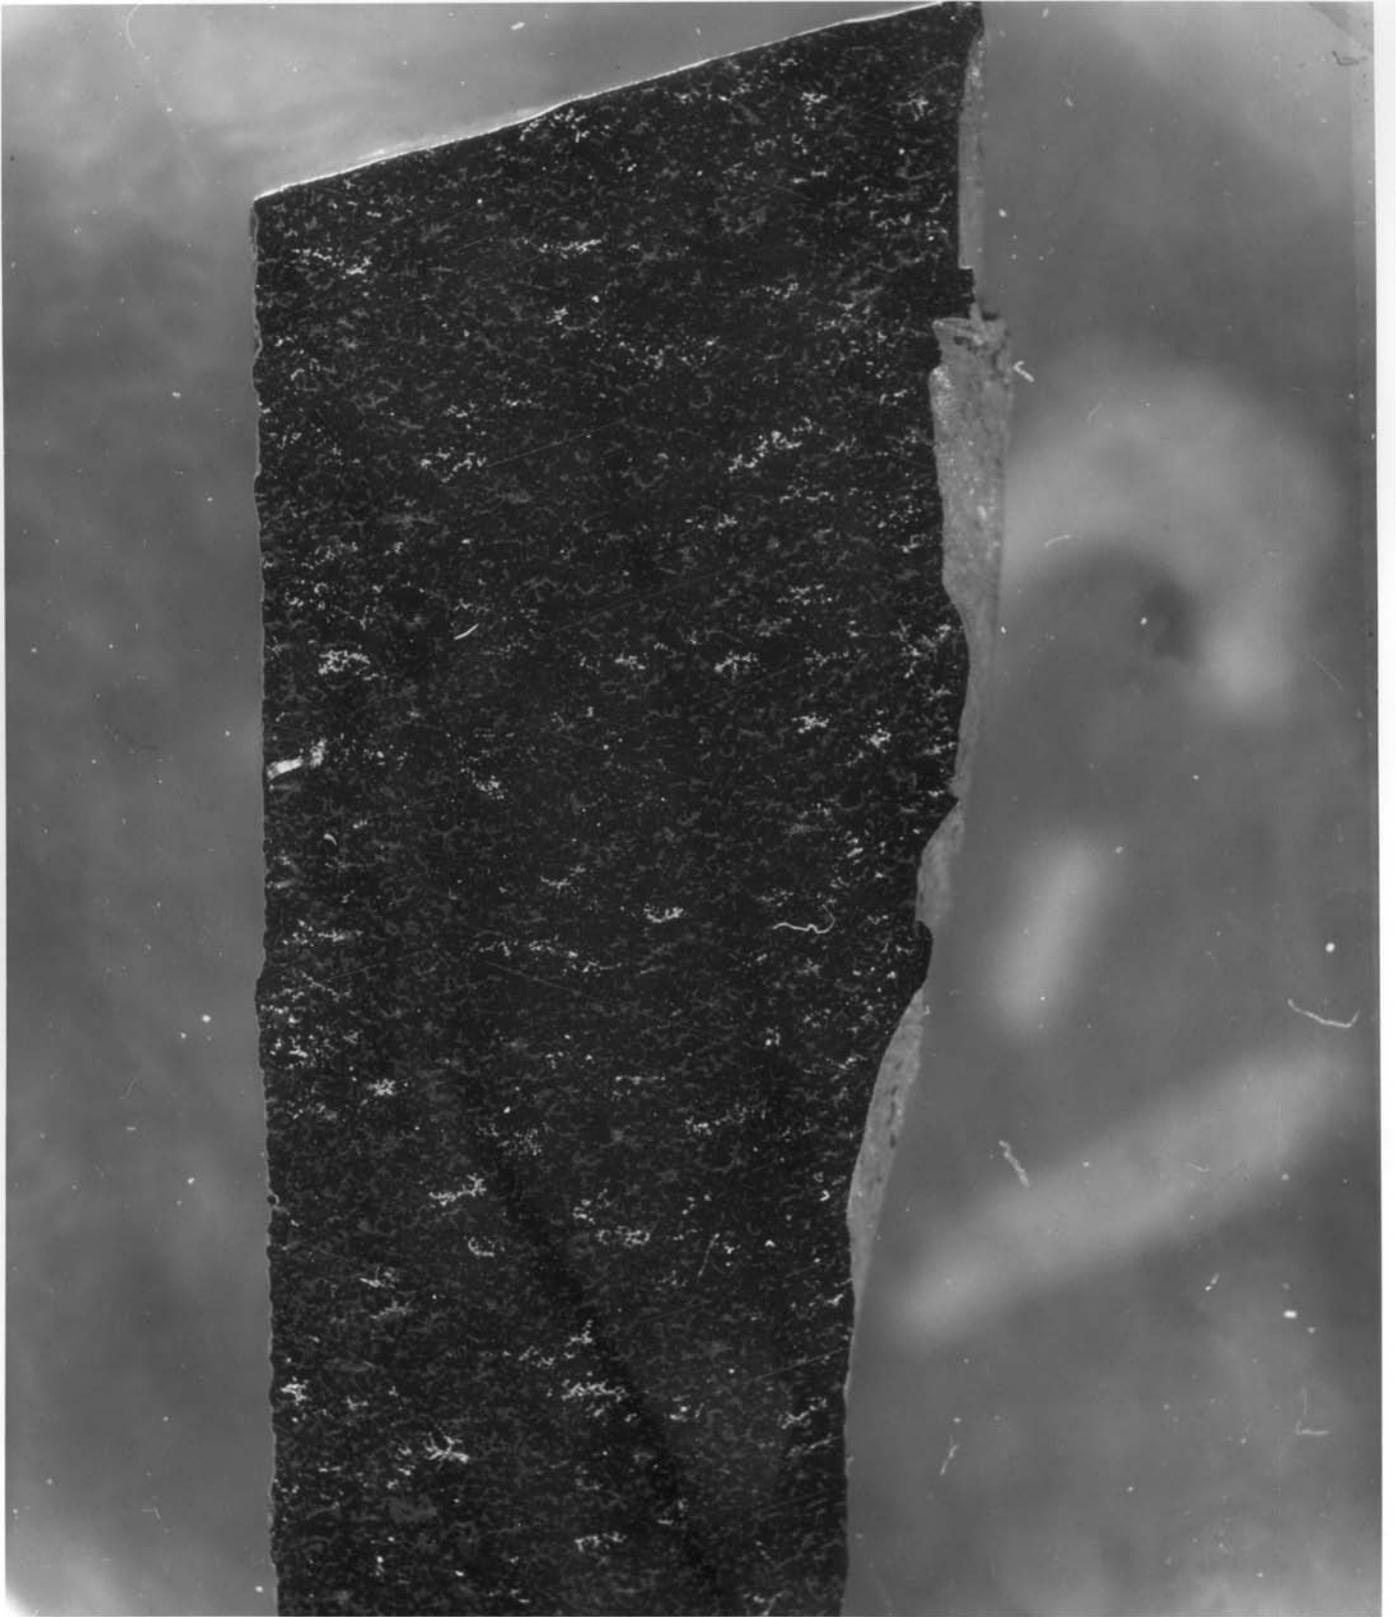
Figs. 6 and 7 are two sections of the same primary casting (Fig. 5) and Fig. 11 is a section of another primary casting (Fig. 10). Extensive white regions, denoting porosity are visible in all three sections. Figs. 8 and 9 show the interior of the primary casting in Fig. 5. Extensive porosity is again seen, of the partly angular, partly rounded, geometry.

Figure 11: Photomicrograph of casting in Fig. 10.
