Report on Fractured Hypodermic Needle

Kenneth C. Russell

Department of Metallurgy and Materials Science

23 April 1970

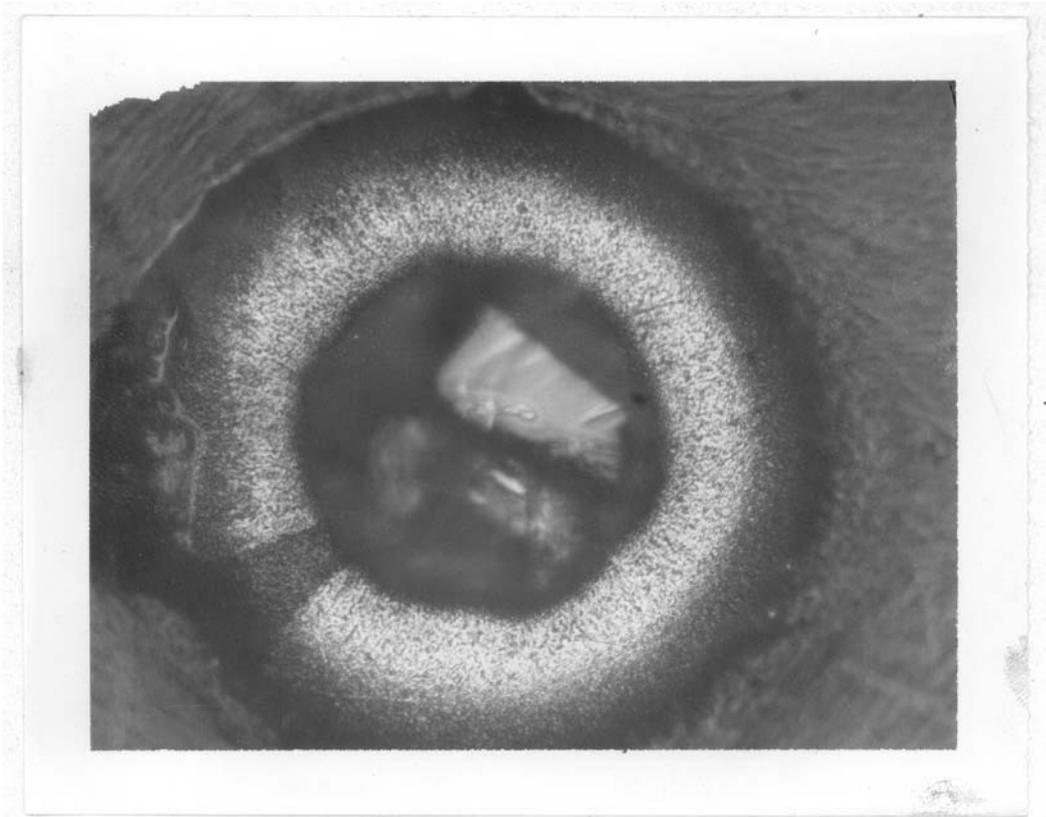
Optical Microscopy (Figure 1) showed that the needles had been formed from welded tubing. Metallography revealed a very fine grain size, characteristic of cold drawing.

Figure 1: Cross section of extra needle showing microstructure and weld. (350X)

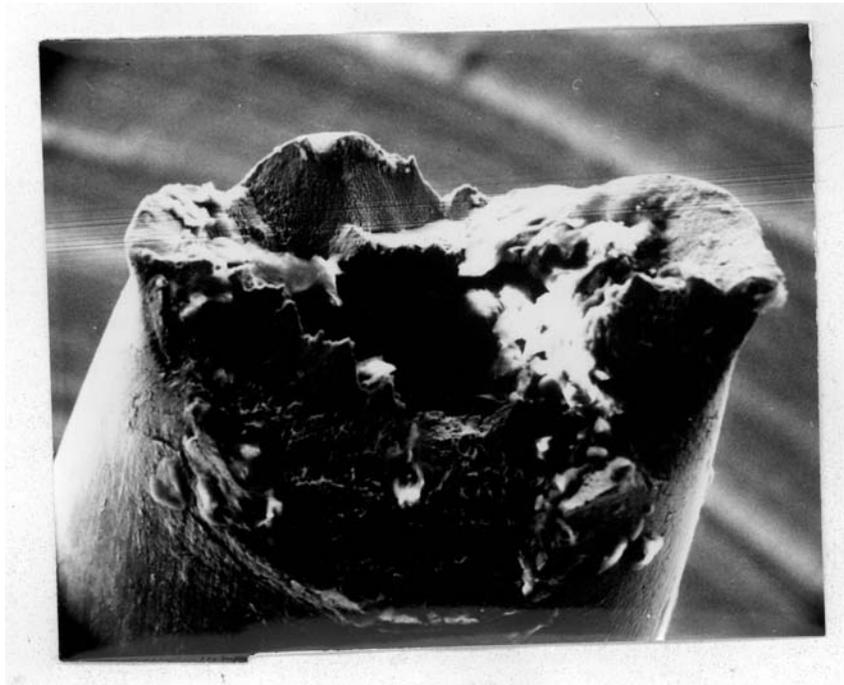
Figures 2-4 show views of the fracture surface of the spare needle which was intentionally broken. In Fig. 2, the overall view, the tension side of the needle is at the top of the picture and the compression side is at the bottom. Compression wrinkles are visible on the curved surface of the needle, near the bottom of the figure. Figures 3 and 4 are magnified views of regions on the top and bottom of Fig. 2, respectively. All three figures show the dimpled, porous fracture surface characteristic of ductile failure. There is no evidence of the planar facets characteristic of brittle fracture.

Figure 2: S.E.M. picture of fracture on extra needle. (260X)

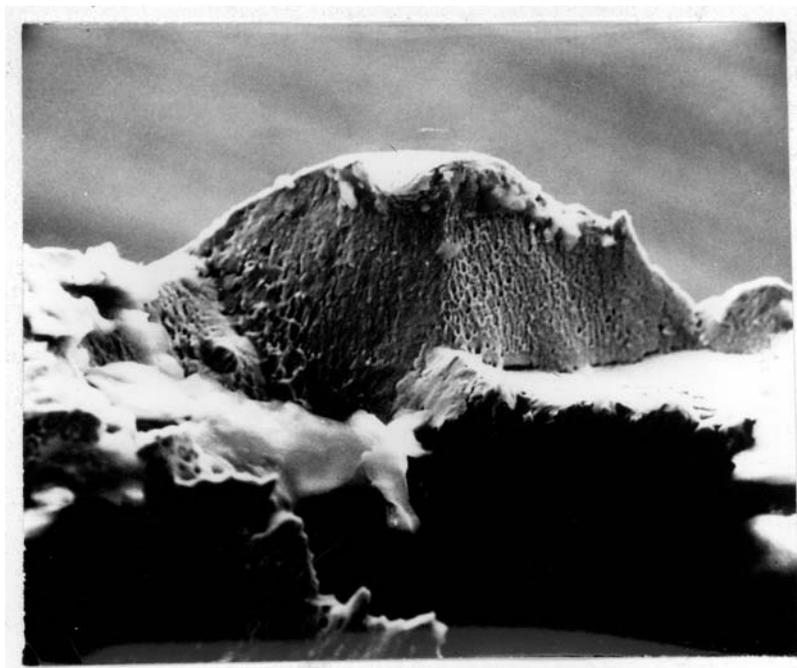
Figure 3: S.E.M. picture of region at 12:00 in Figure 2. (650X)

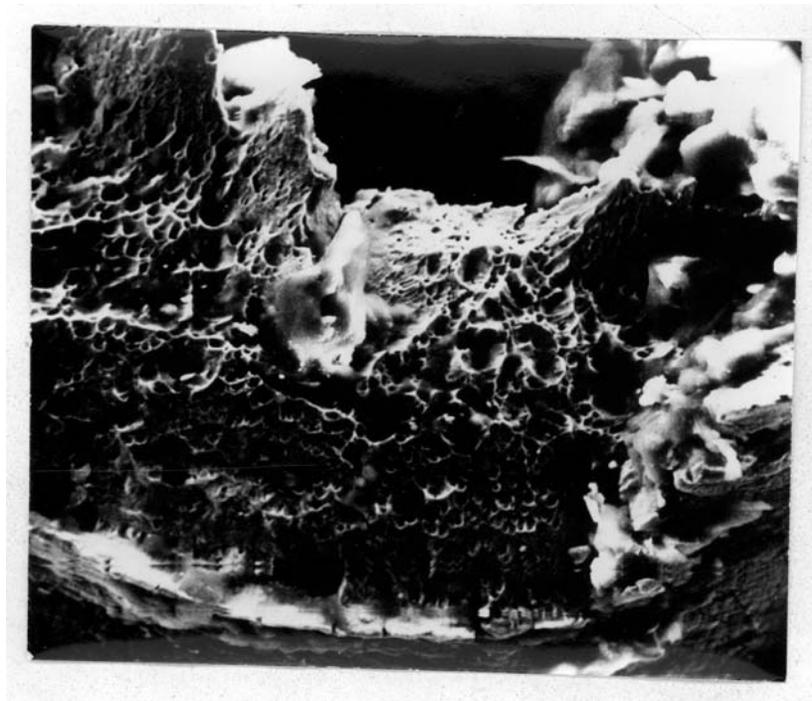
Figure 4: S.E.M. picture of region at 6:00 in Figure 2. (650X)

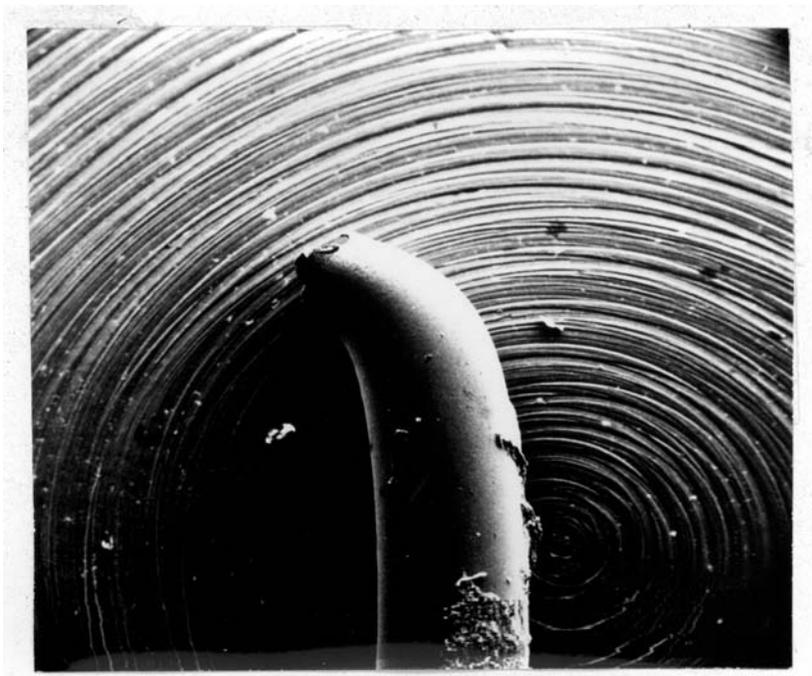
Figure 5 is a plan view of the extra needle, laid flat on the S.E.M. stage. One observes the extensive deflection that occurred prior to fracture.

Figure 5: Plan view of needle showing bending that occurred before fracture. (64X)

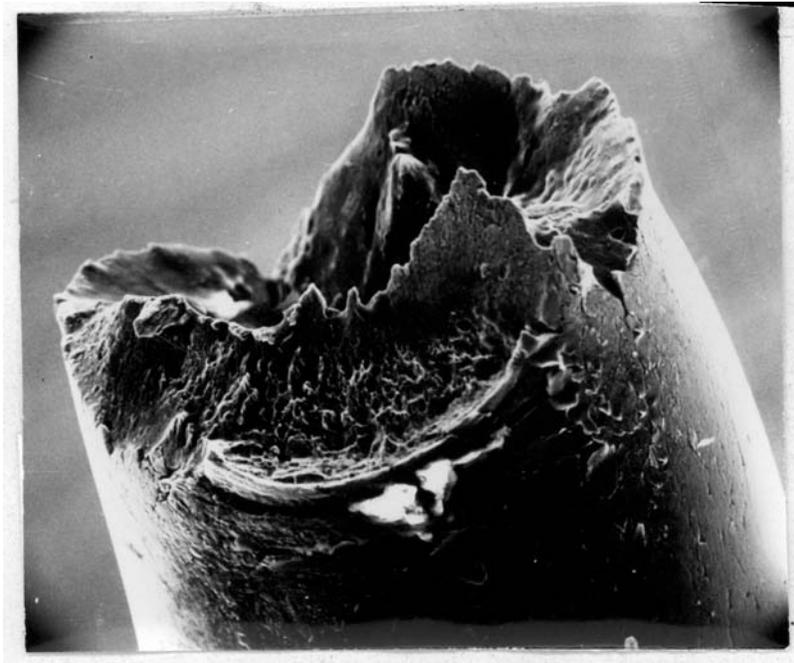
Figures 6-11 show S.E.M. photographs of the subject needle, involved in the litigation. In Fig. 6 the compression side, identifiable by the wrinkles, is at the bottom of the figure and the tension side is at the top. The entire fracture surface was scanned by the microscope, with particular attention paid any areas suggestive of brittle fracture.

Figure 6: S.E.M. picture of fracture surface in subject needle. (280X)

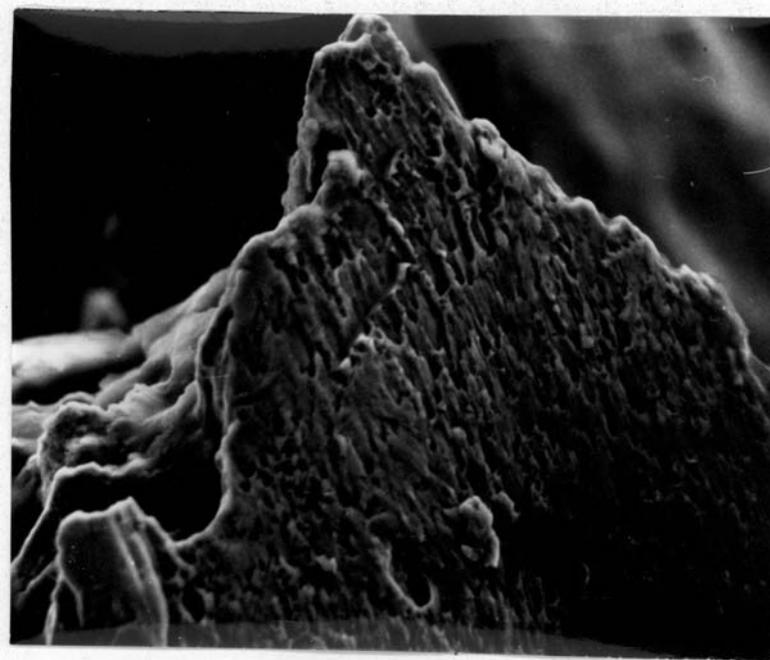
Figure 7 shows the peak at about 5:00 on the needle (taking the tensile side as 12:00 and the compression side as 6:00). Although this area looks like a facet in Fig. 6, Fig. 7 shows the dimpling characteristic of ductile failure.

Figure 7: S.E.M. picture of region at 6:00 in Figure 6. (680X)
