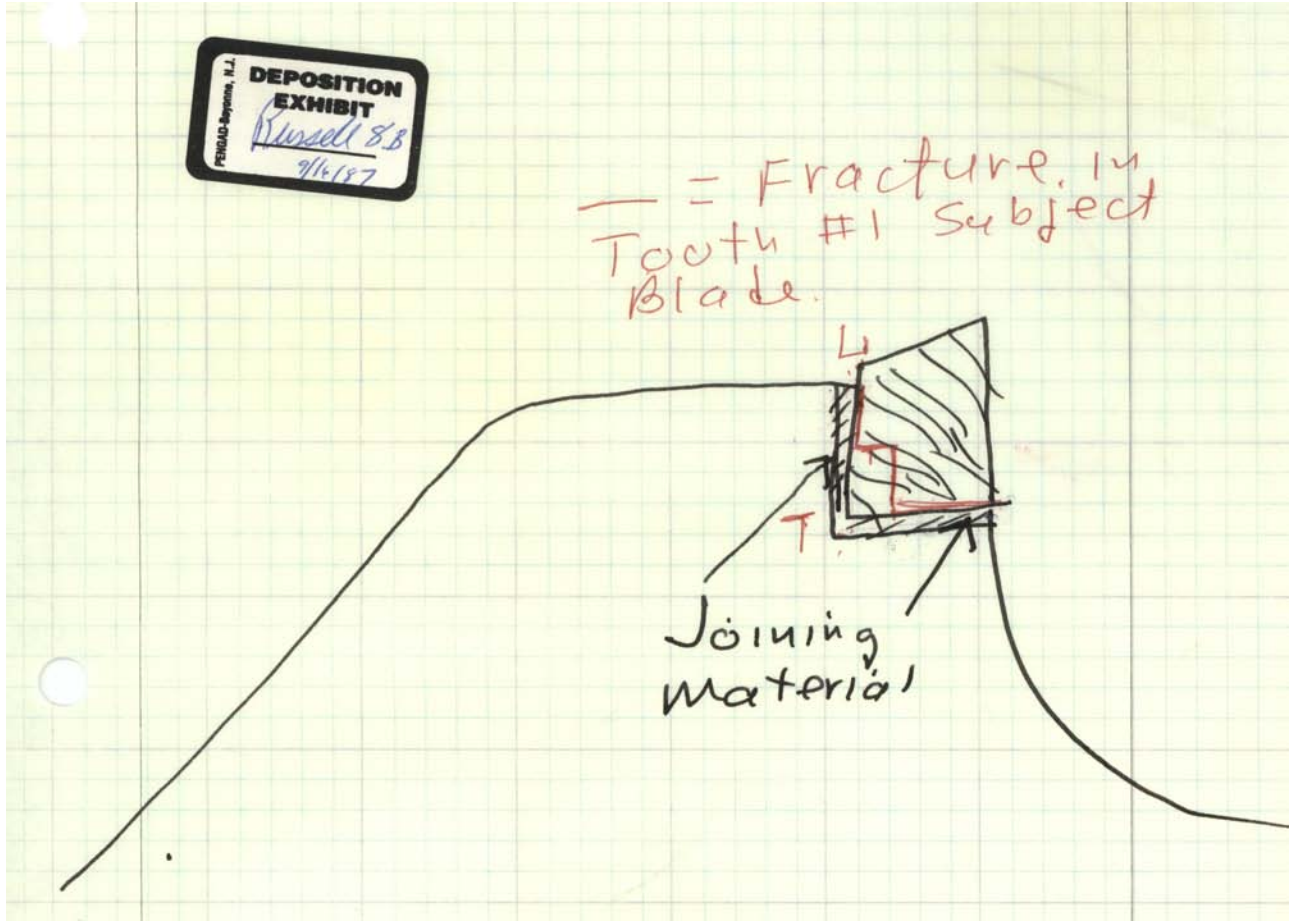
Figure 1: Schematic of saw blade, showing how the carbide tooth fractured both along the join and through the carbide.

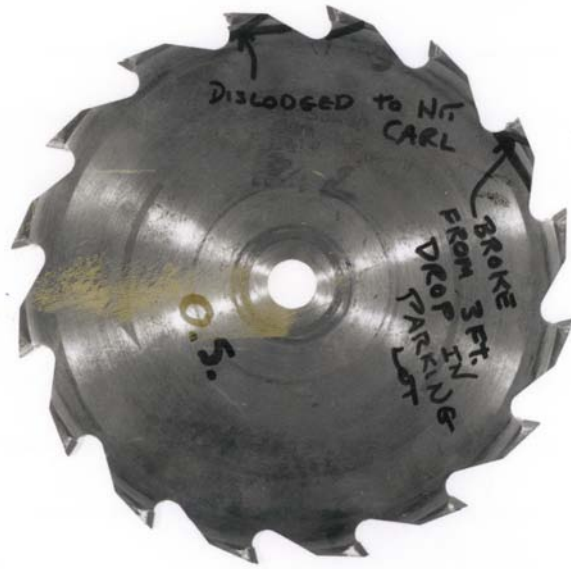
Figure 2: Subject blade, showing multiple broken teeth.

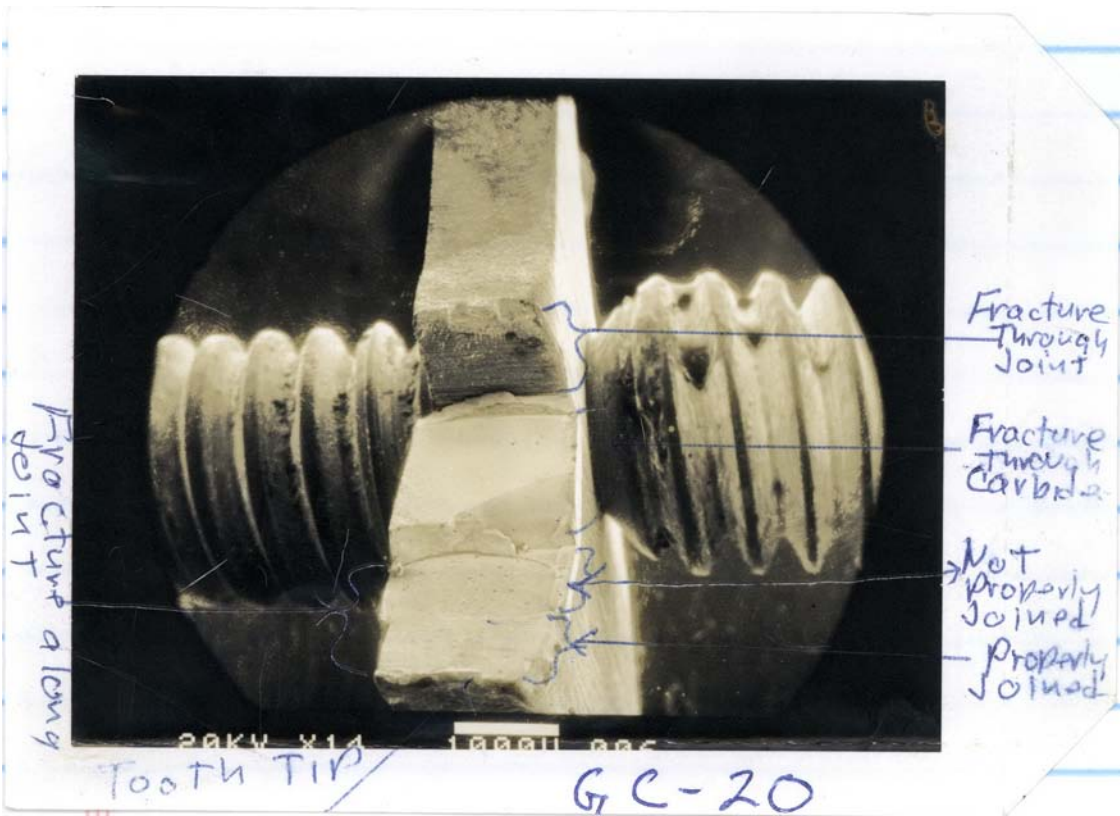
Figure 3: Detached tooth No. 1 in SEM mount, edge-on, showing fracture through the joint and the carbide.
